Roof Survey Report

Downton Heights

10th March 2022

FSU0001

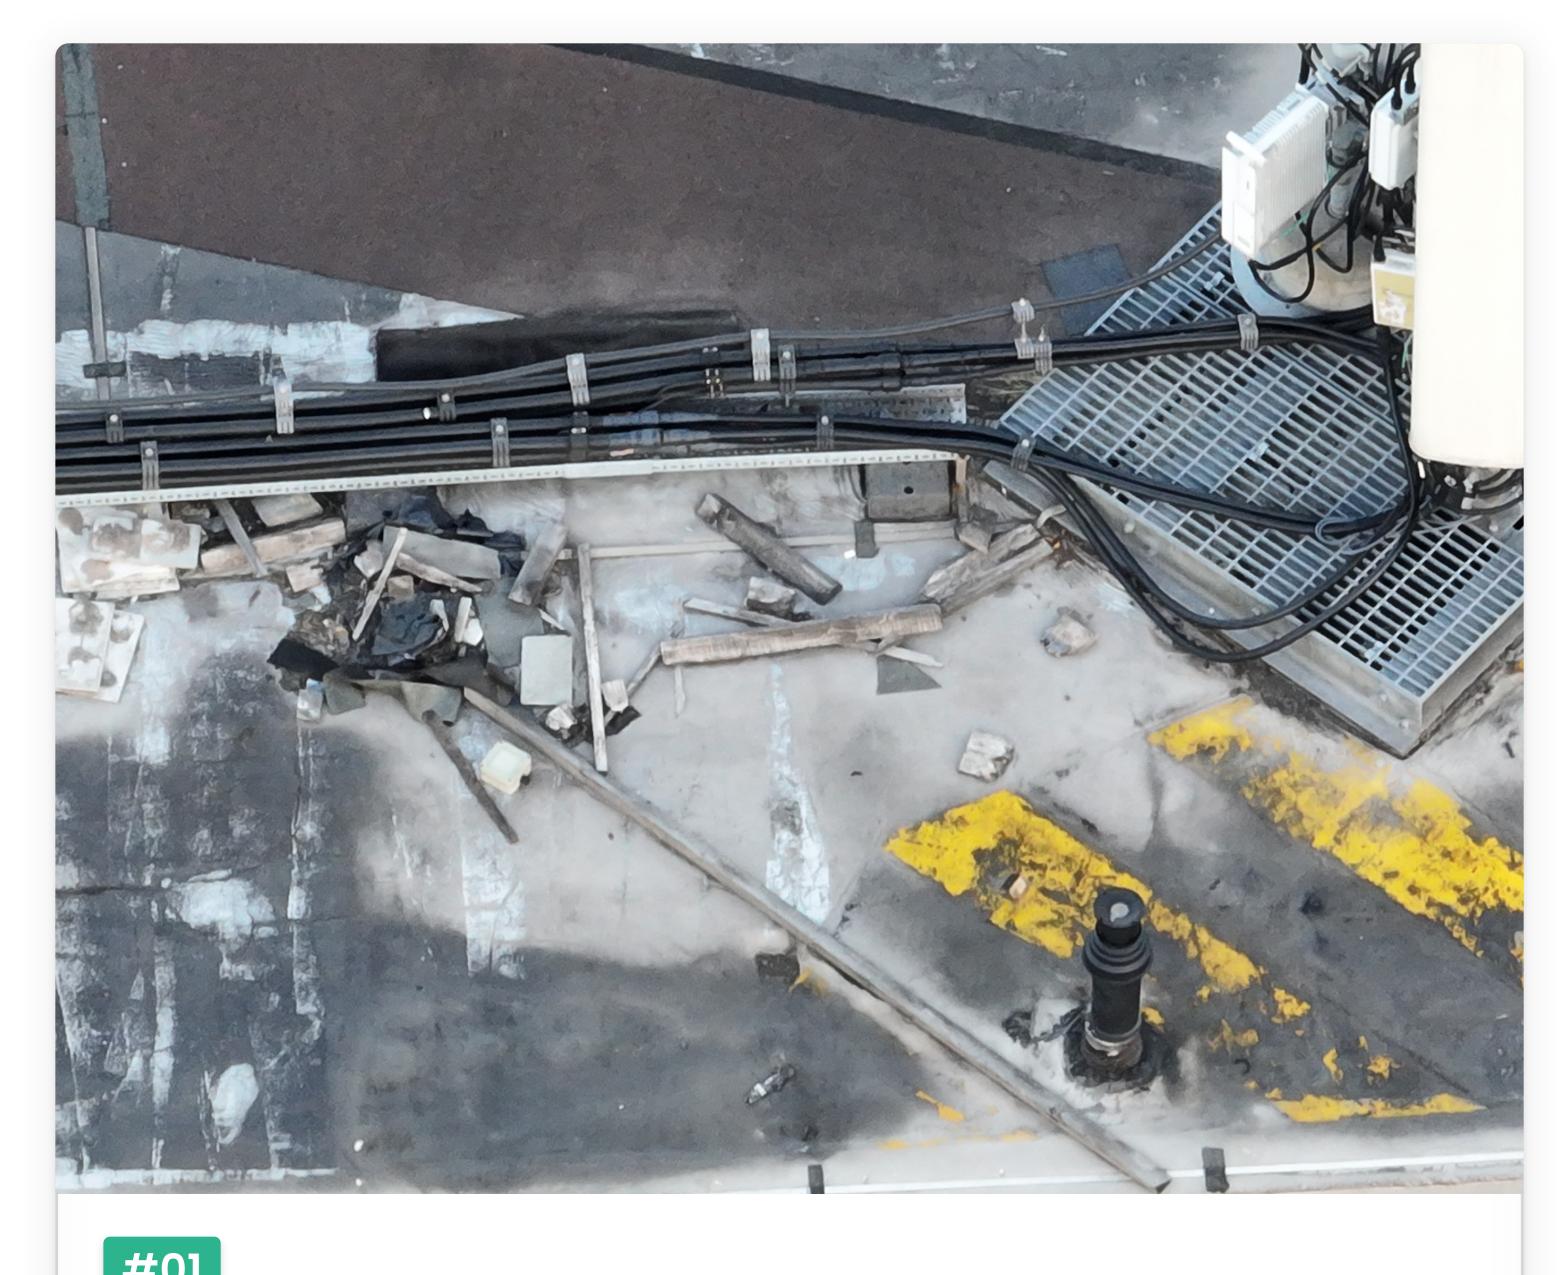
Loose materials laid across roof membrane

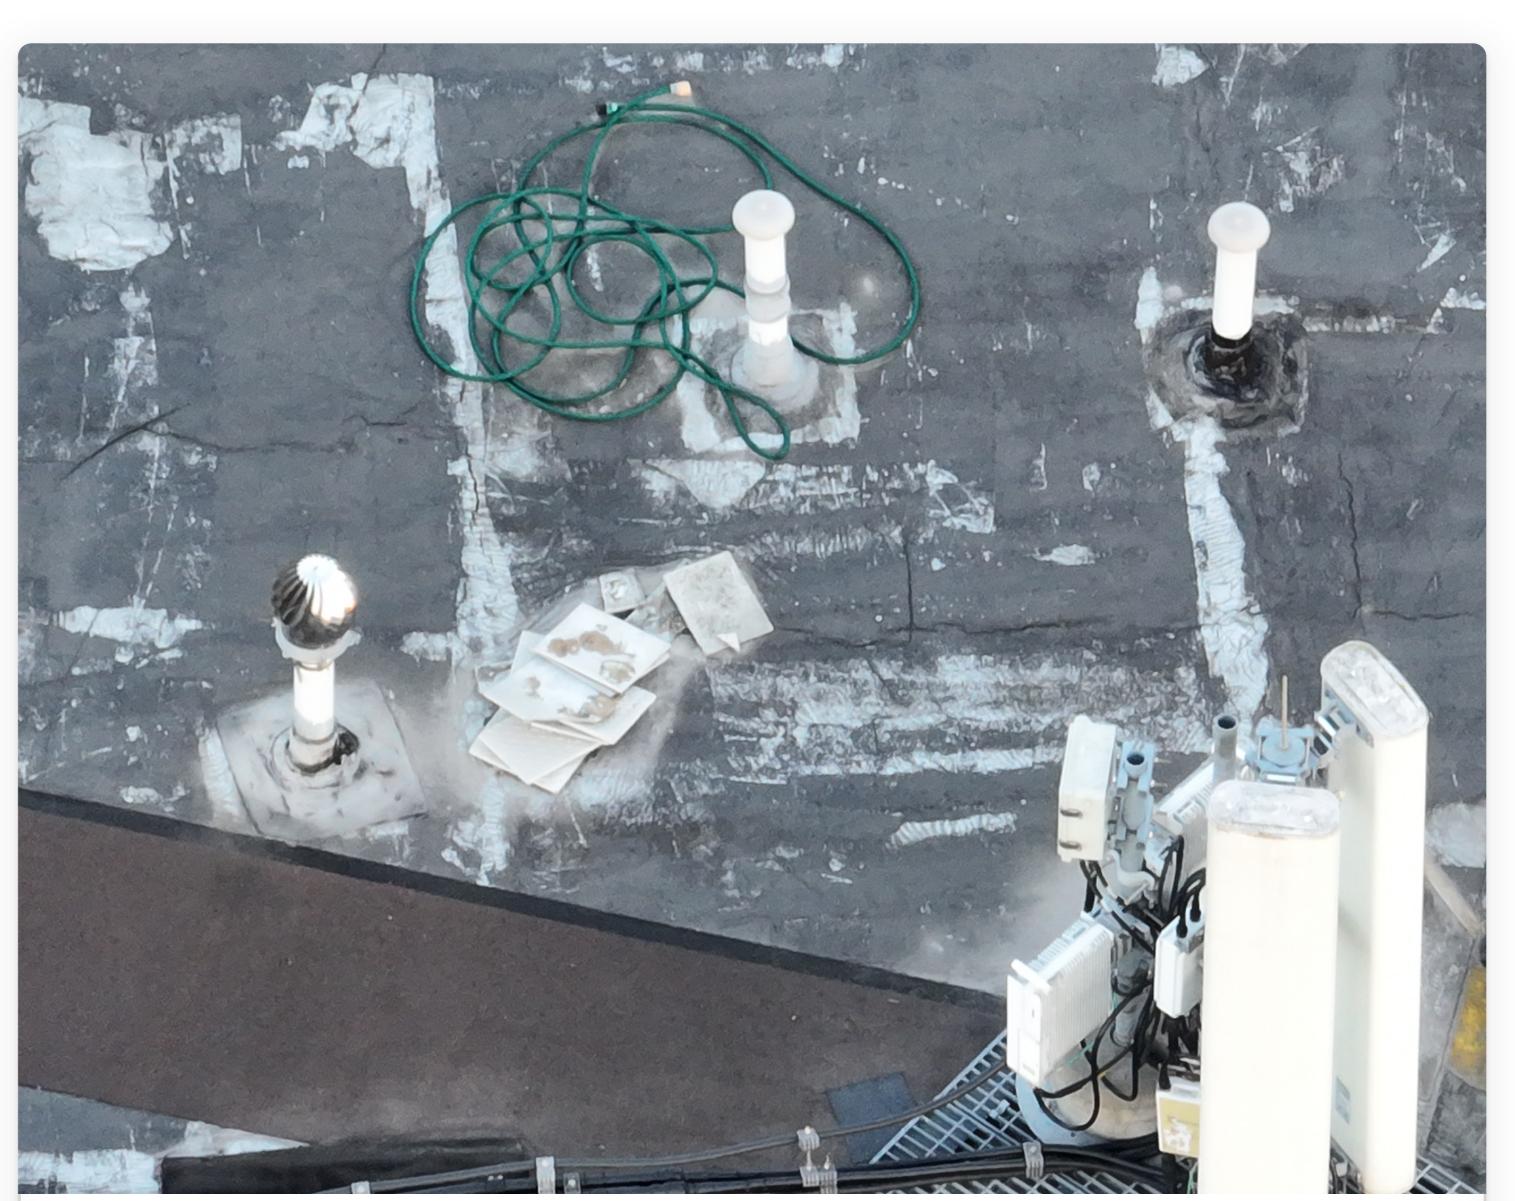
Loose materials across roof membrane

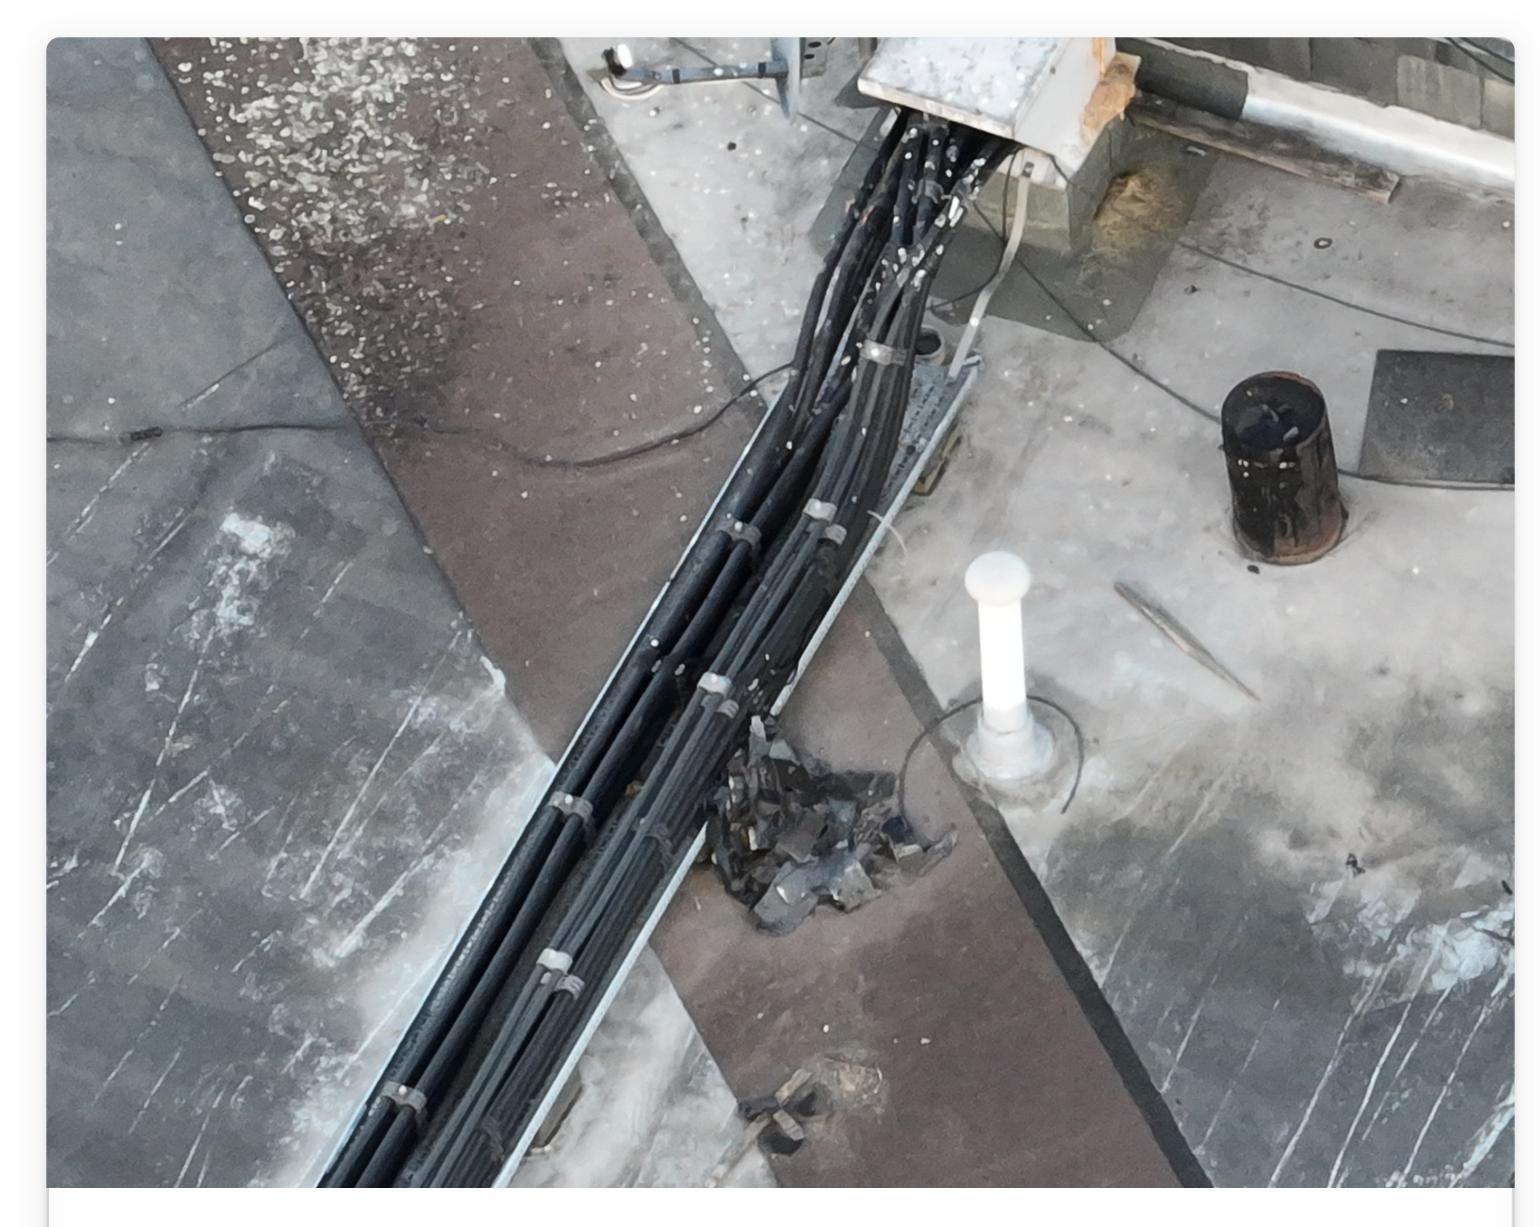
#03

Discarded clips and waste laid beside cable tray along with other waste

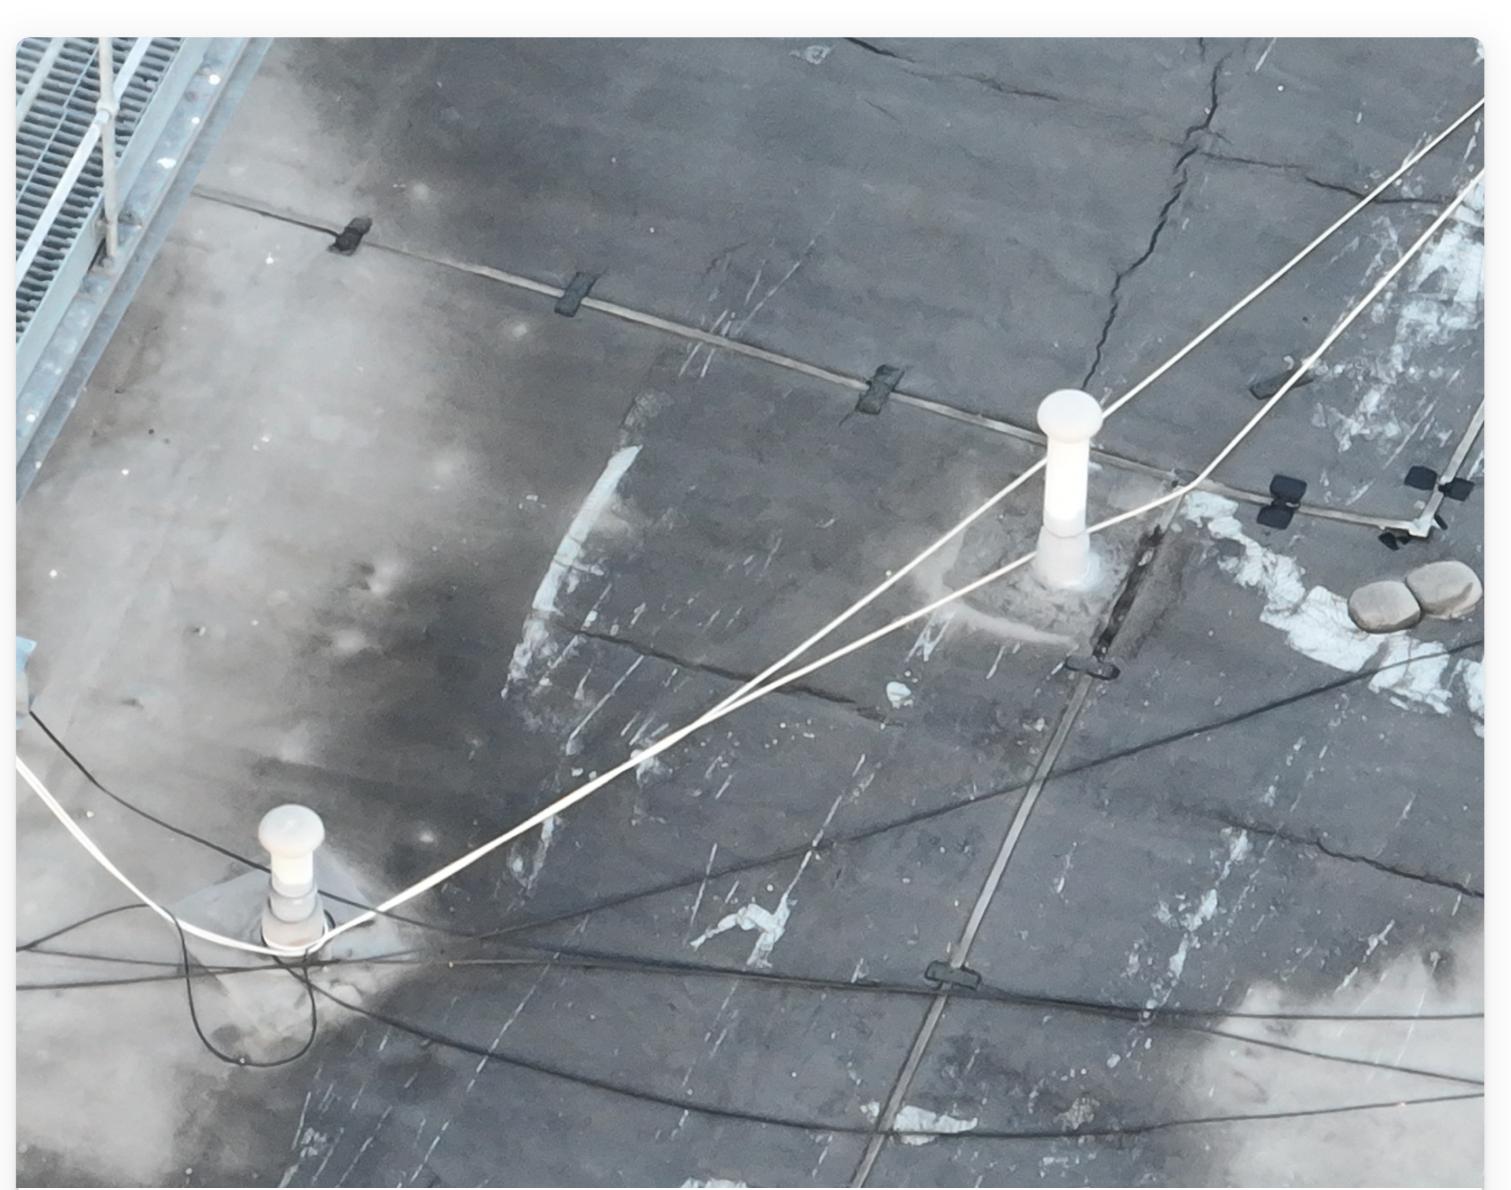
#04

Tangled cables presenting significant hazard trip on the roof

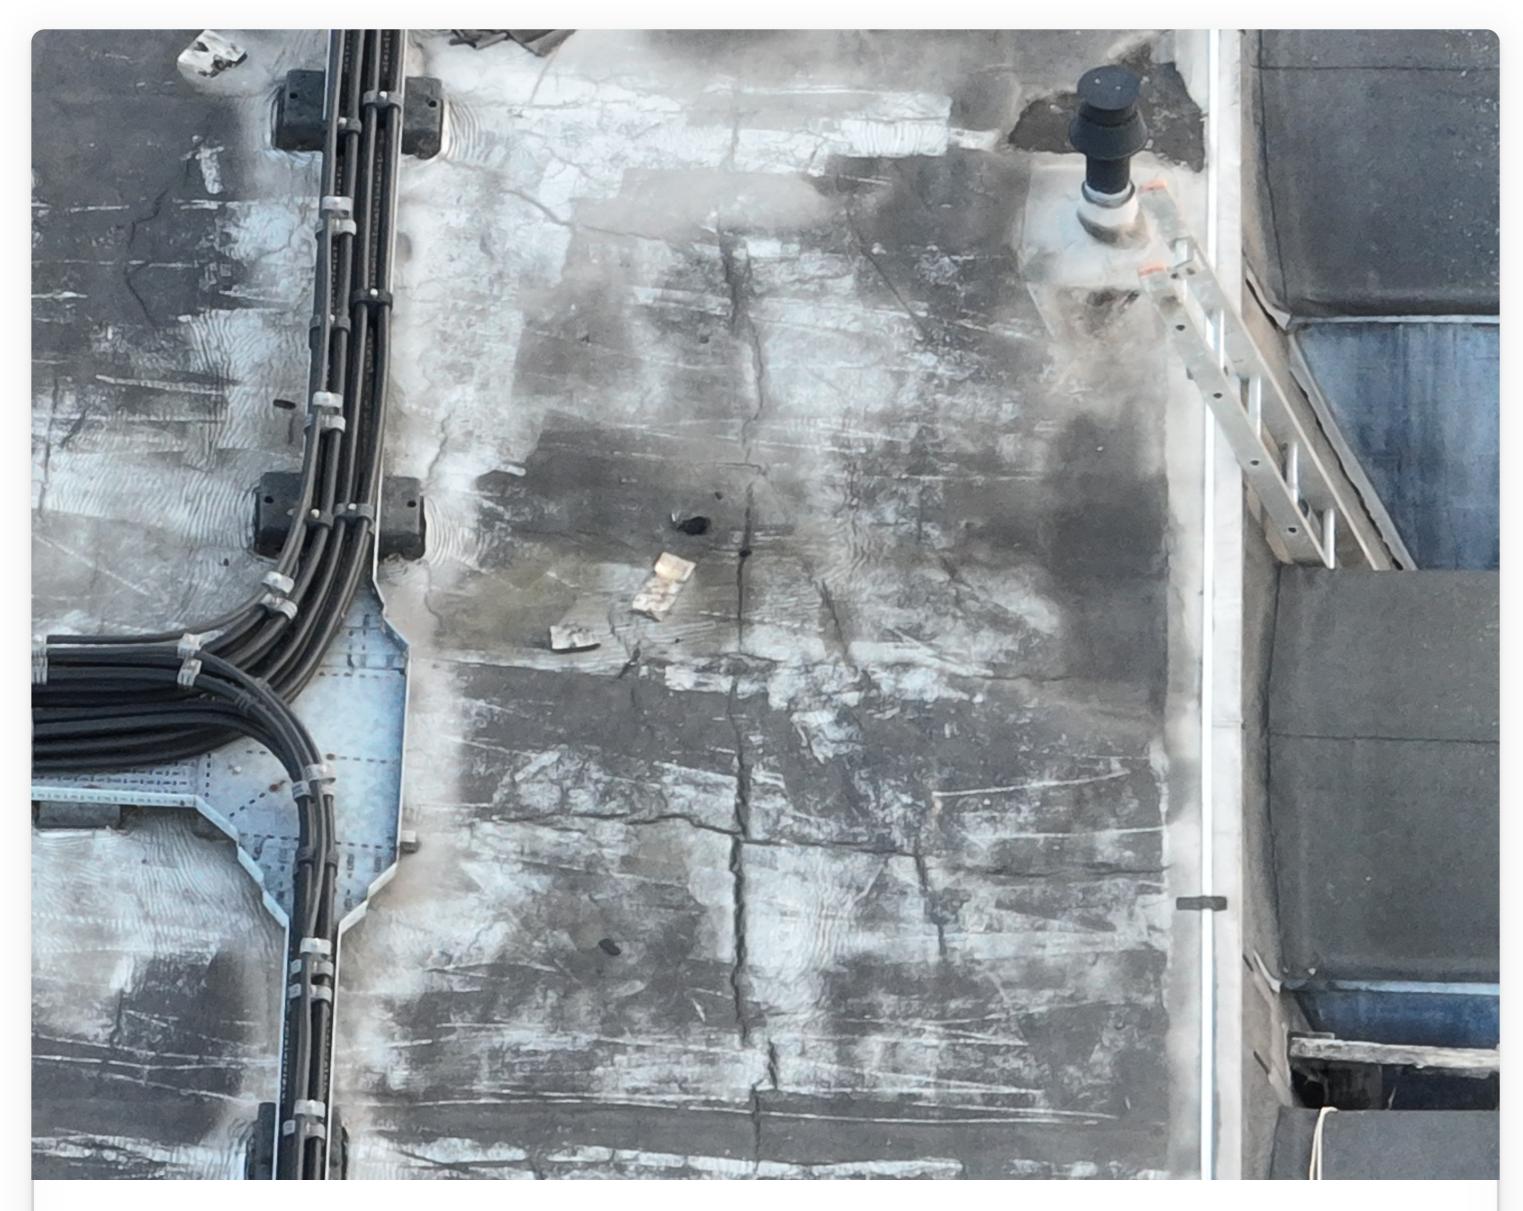
#05

From aerial photos it can be seen there is significant scars and marks on roof membrane. Precaution to be taken to protect membrane from damages as a result of works on the roof.

Significant scars/marks on membrane. Current depth unable to be verified without direct access

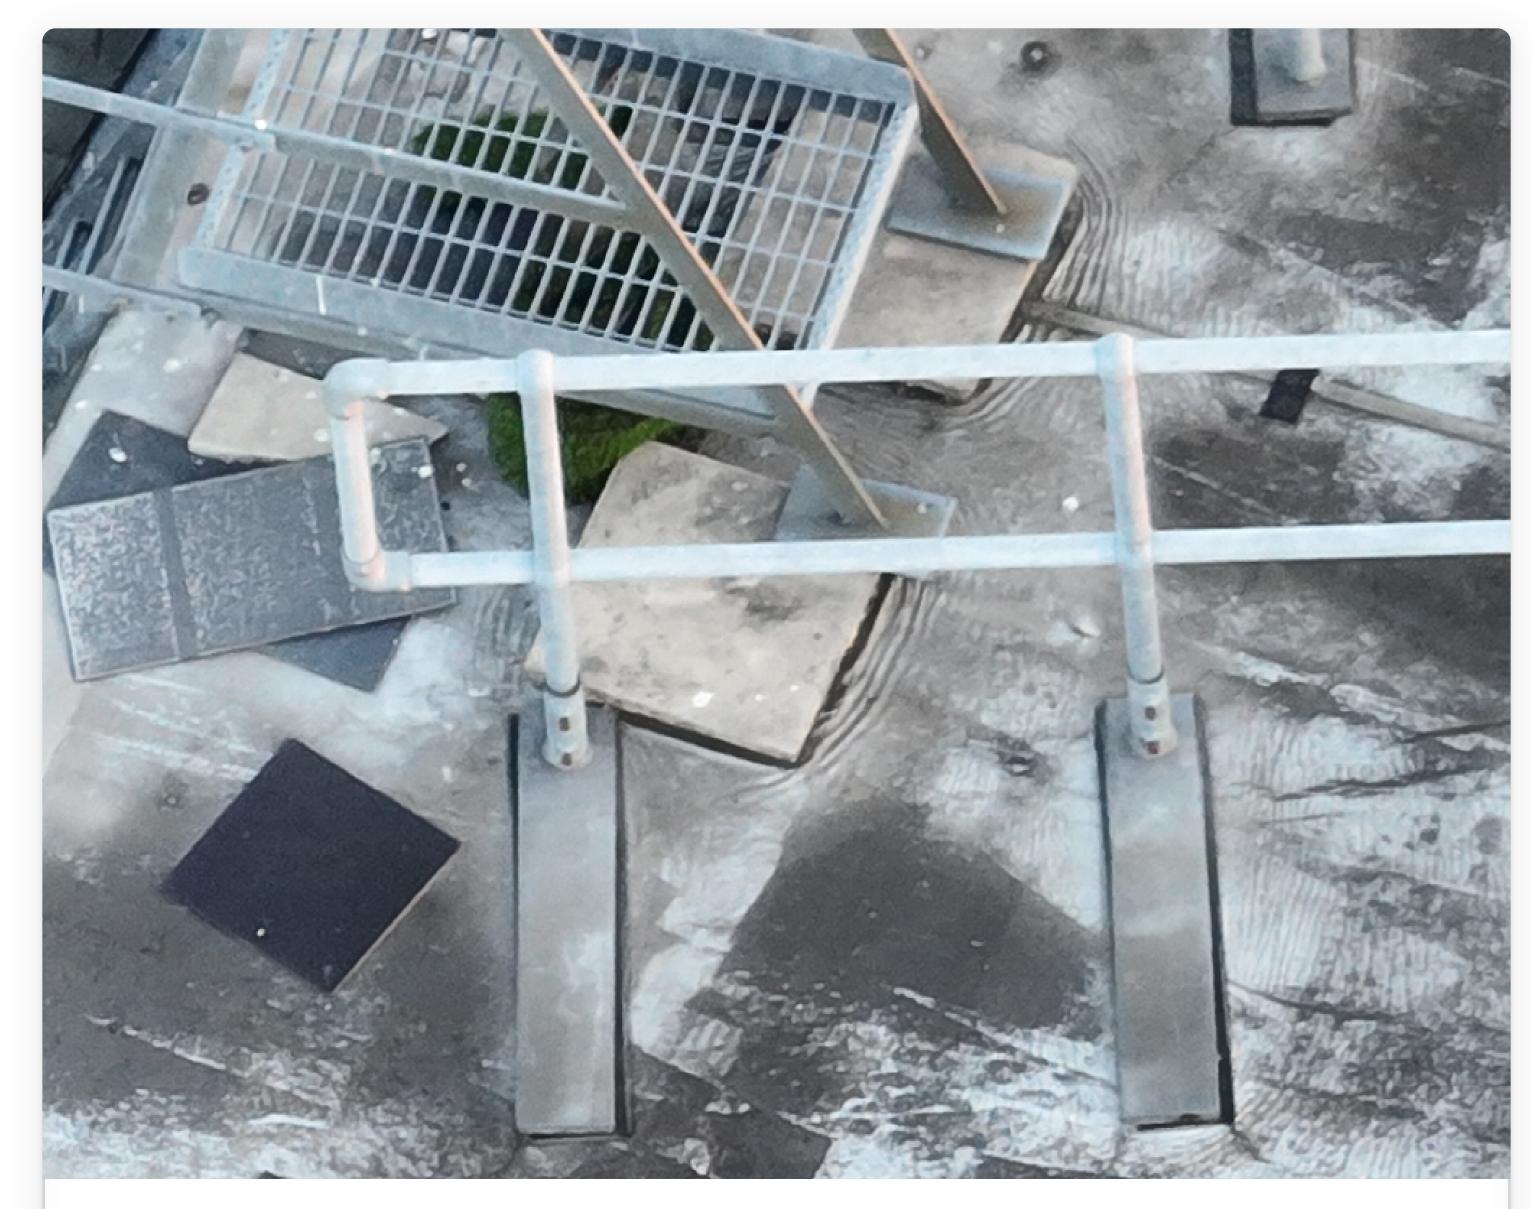
#06

Strain induced onto the roof membrane as a result of weight handrail base shifting

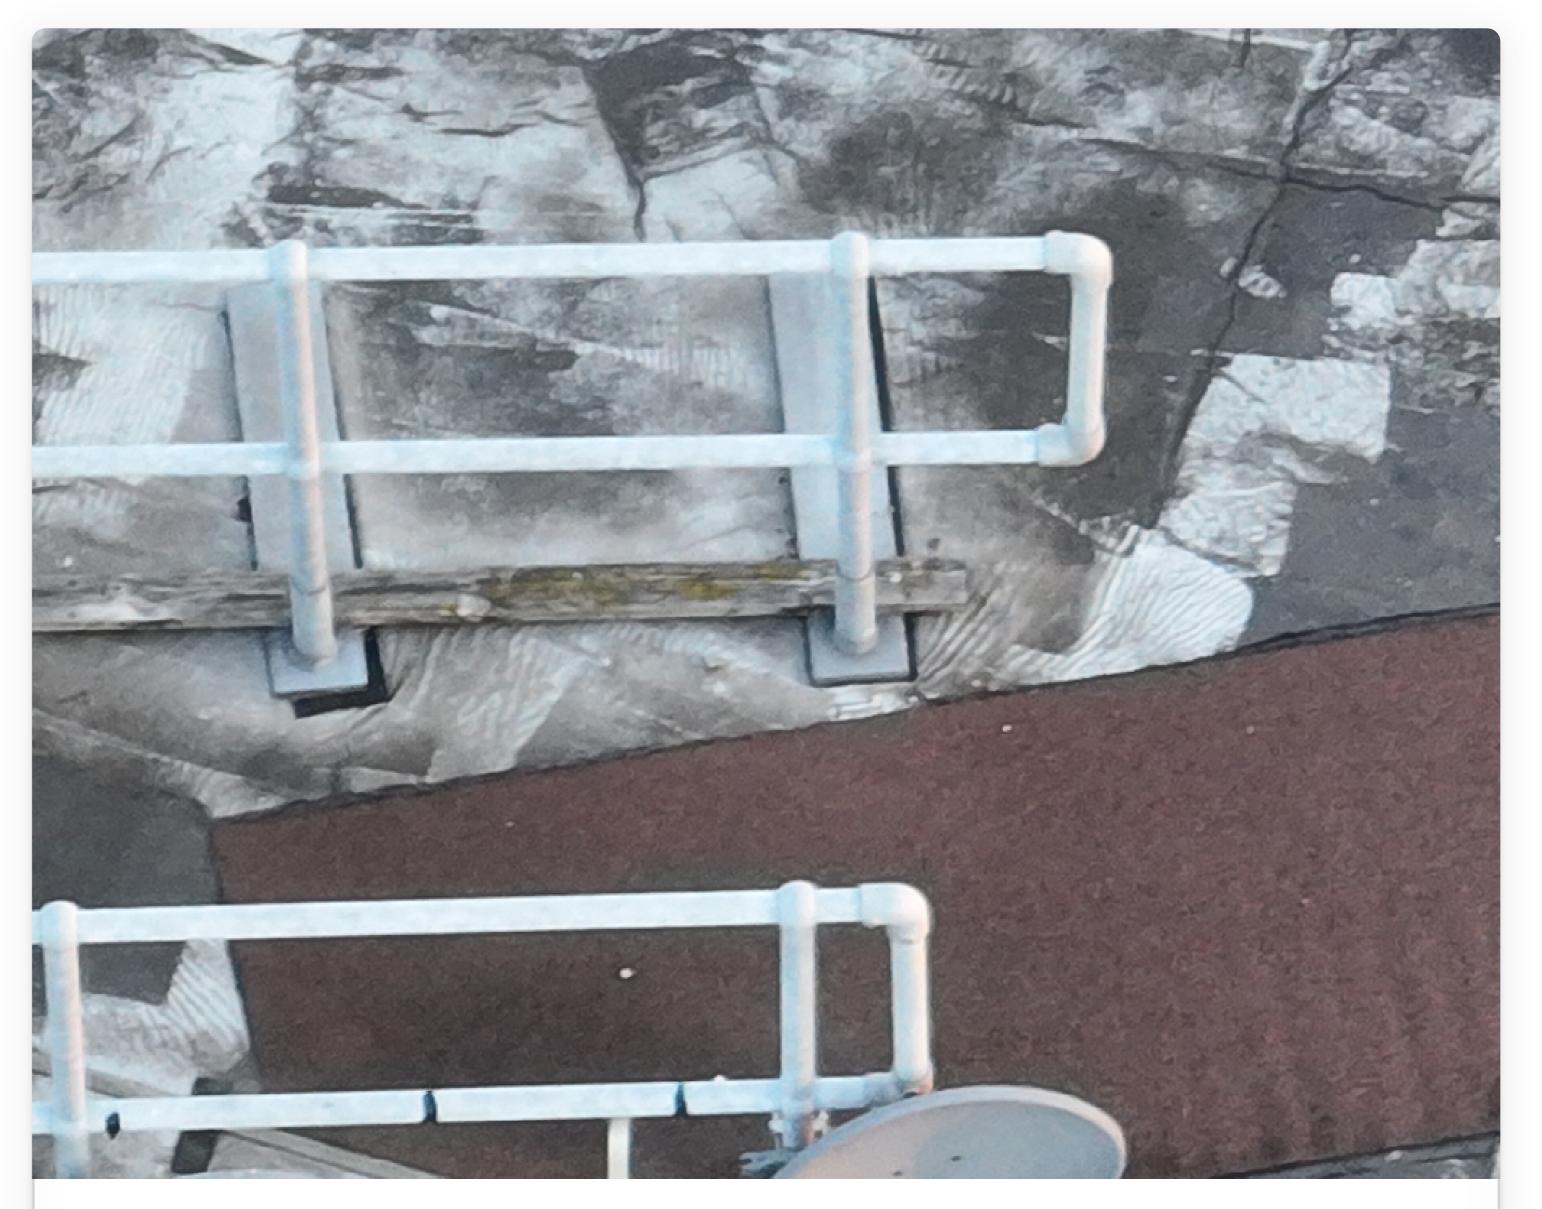
#07

Strain induced onto the roof membrane as a result of weight handrail base shifting

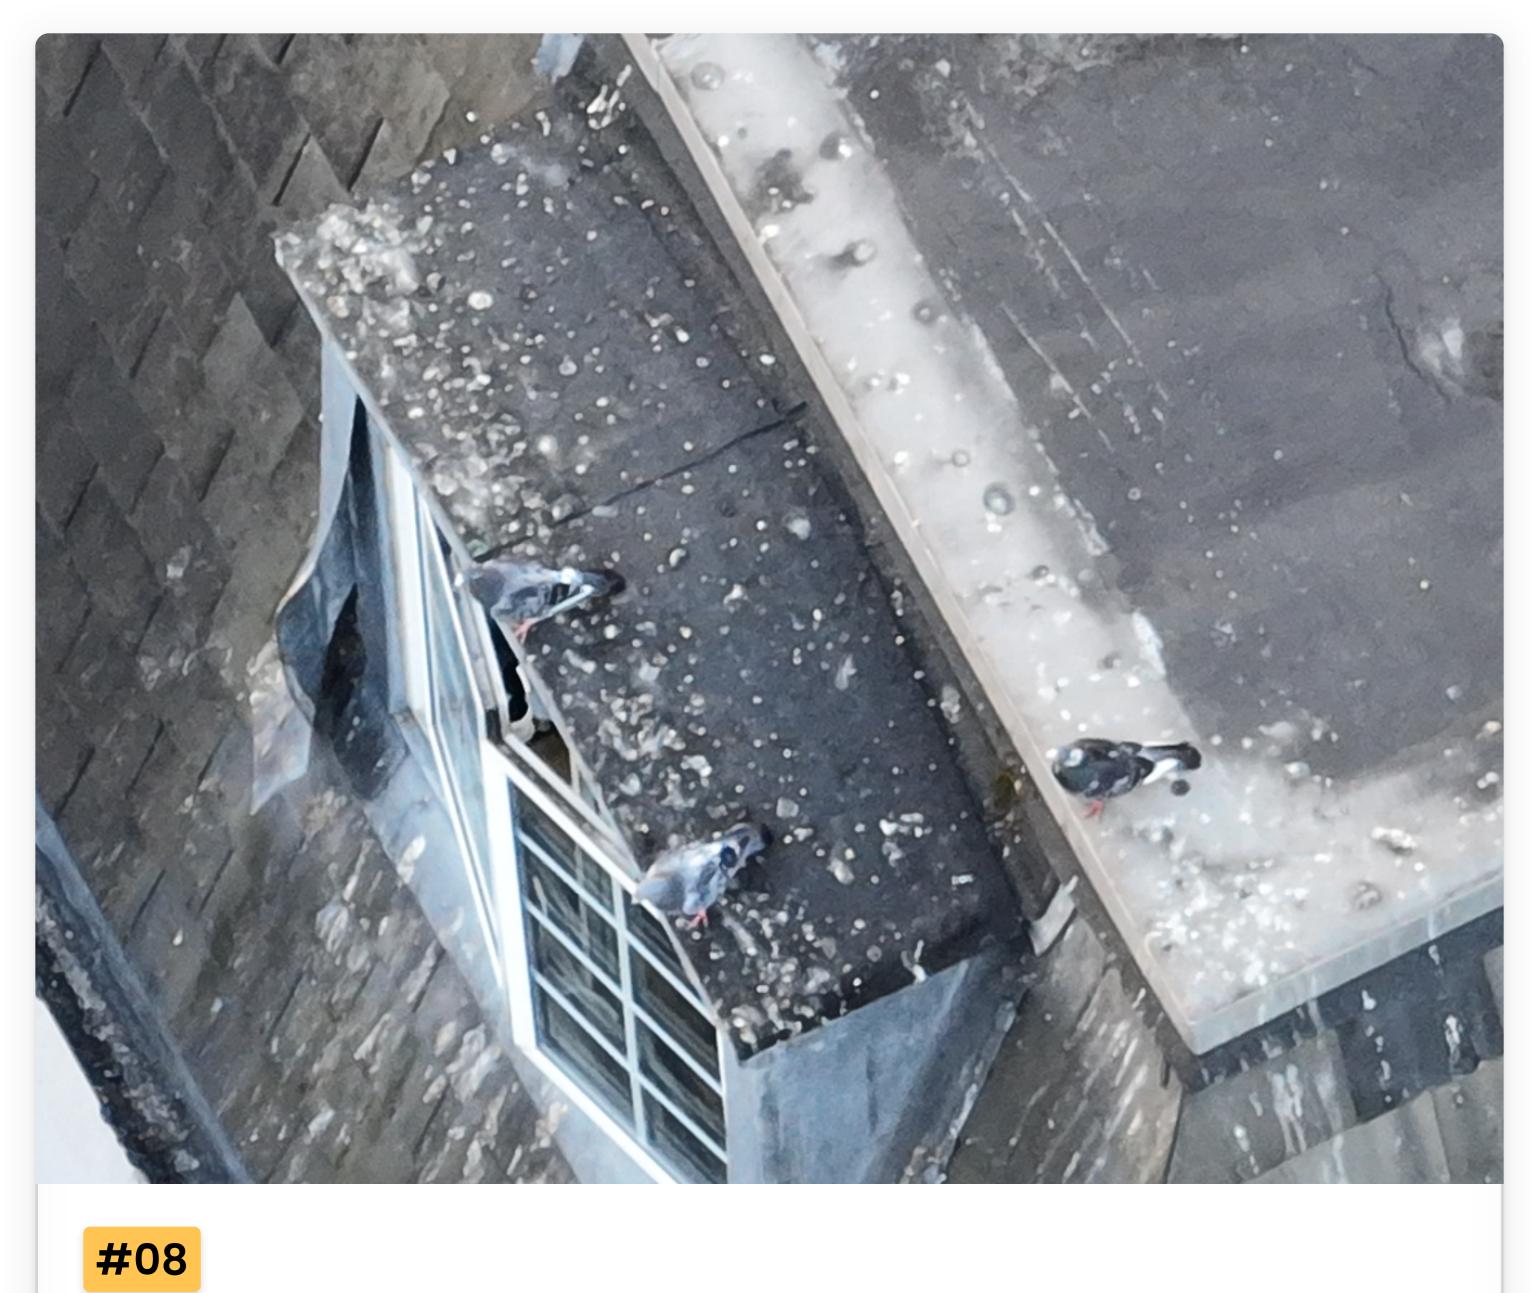
Bird faeces building on up roof South-East corner of building
