Frame Bound Surveys

Roof Survey Report

Harlesden Court

17th March 2022

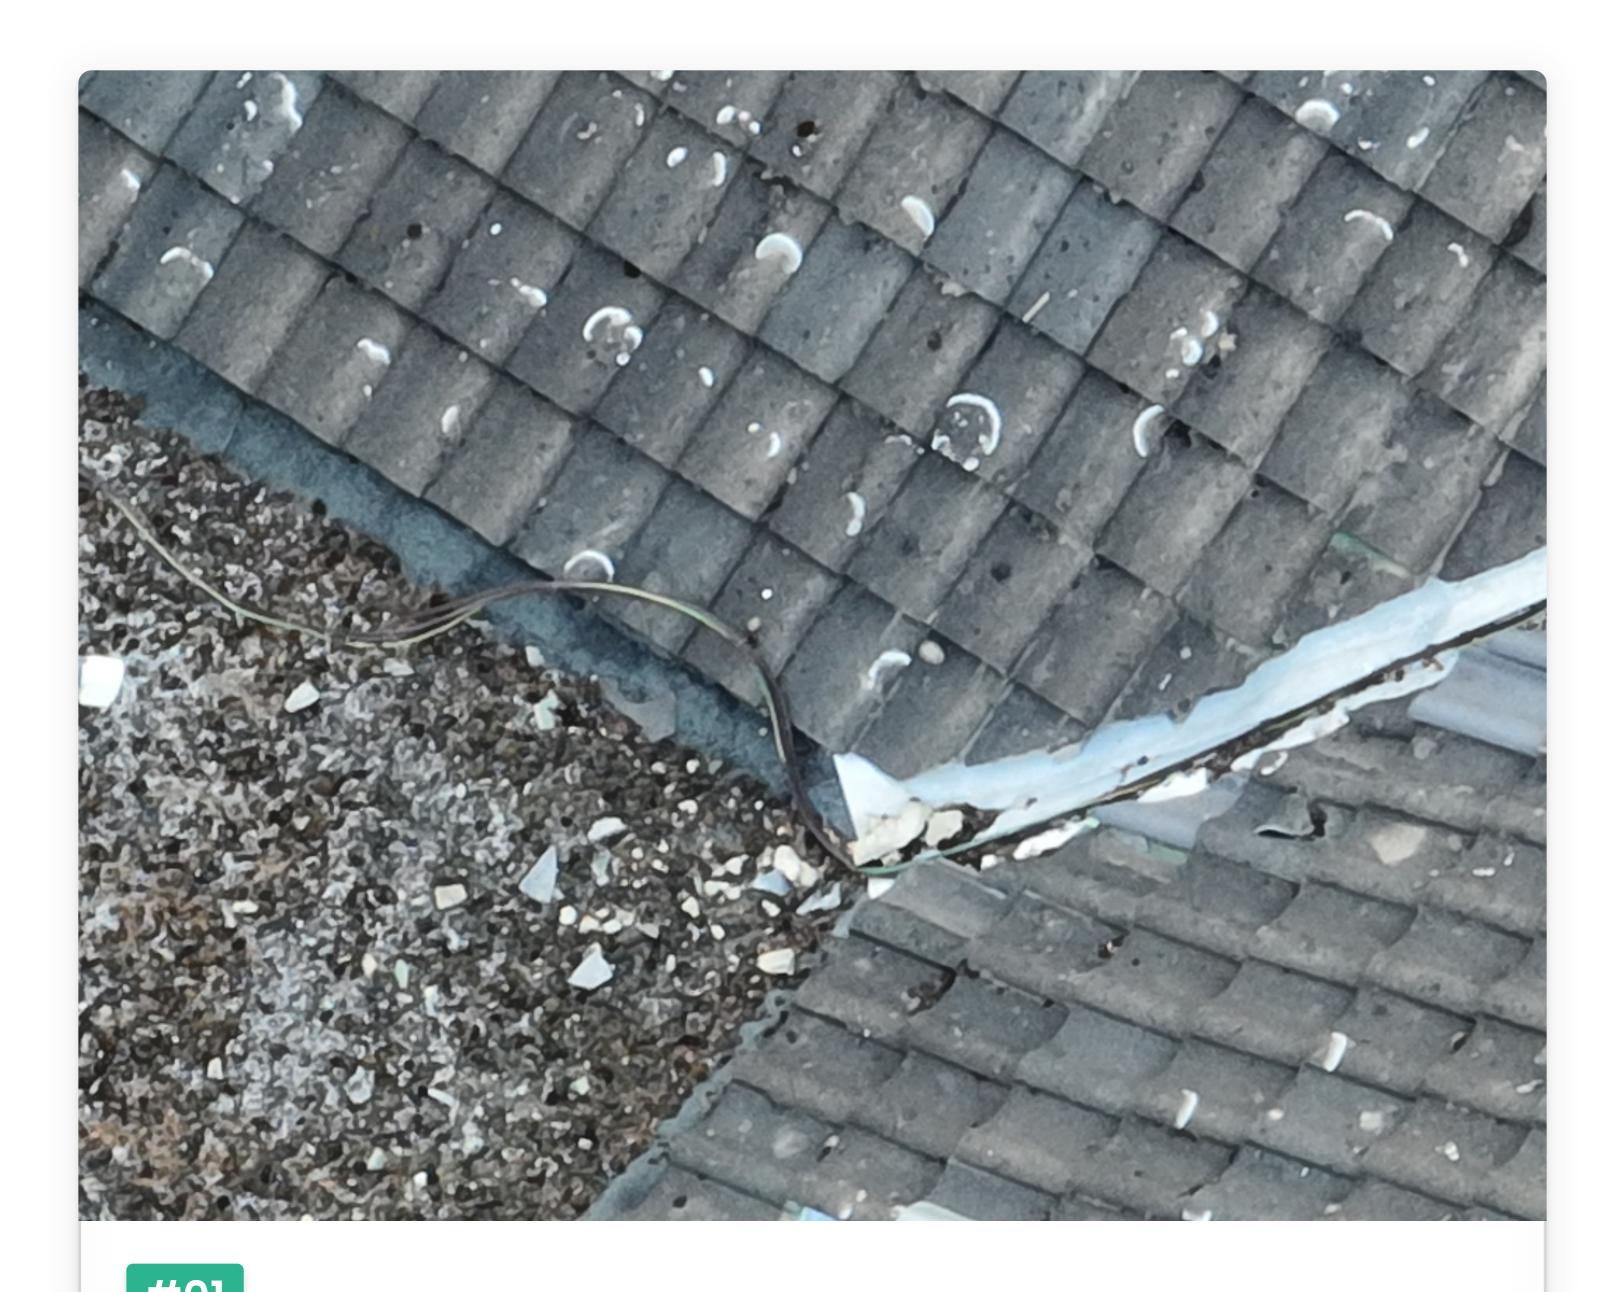
Damaged membrane due to antenna cable route. Further observation on joint required to determine impact.

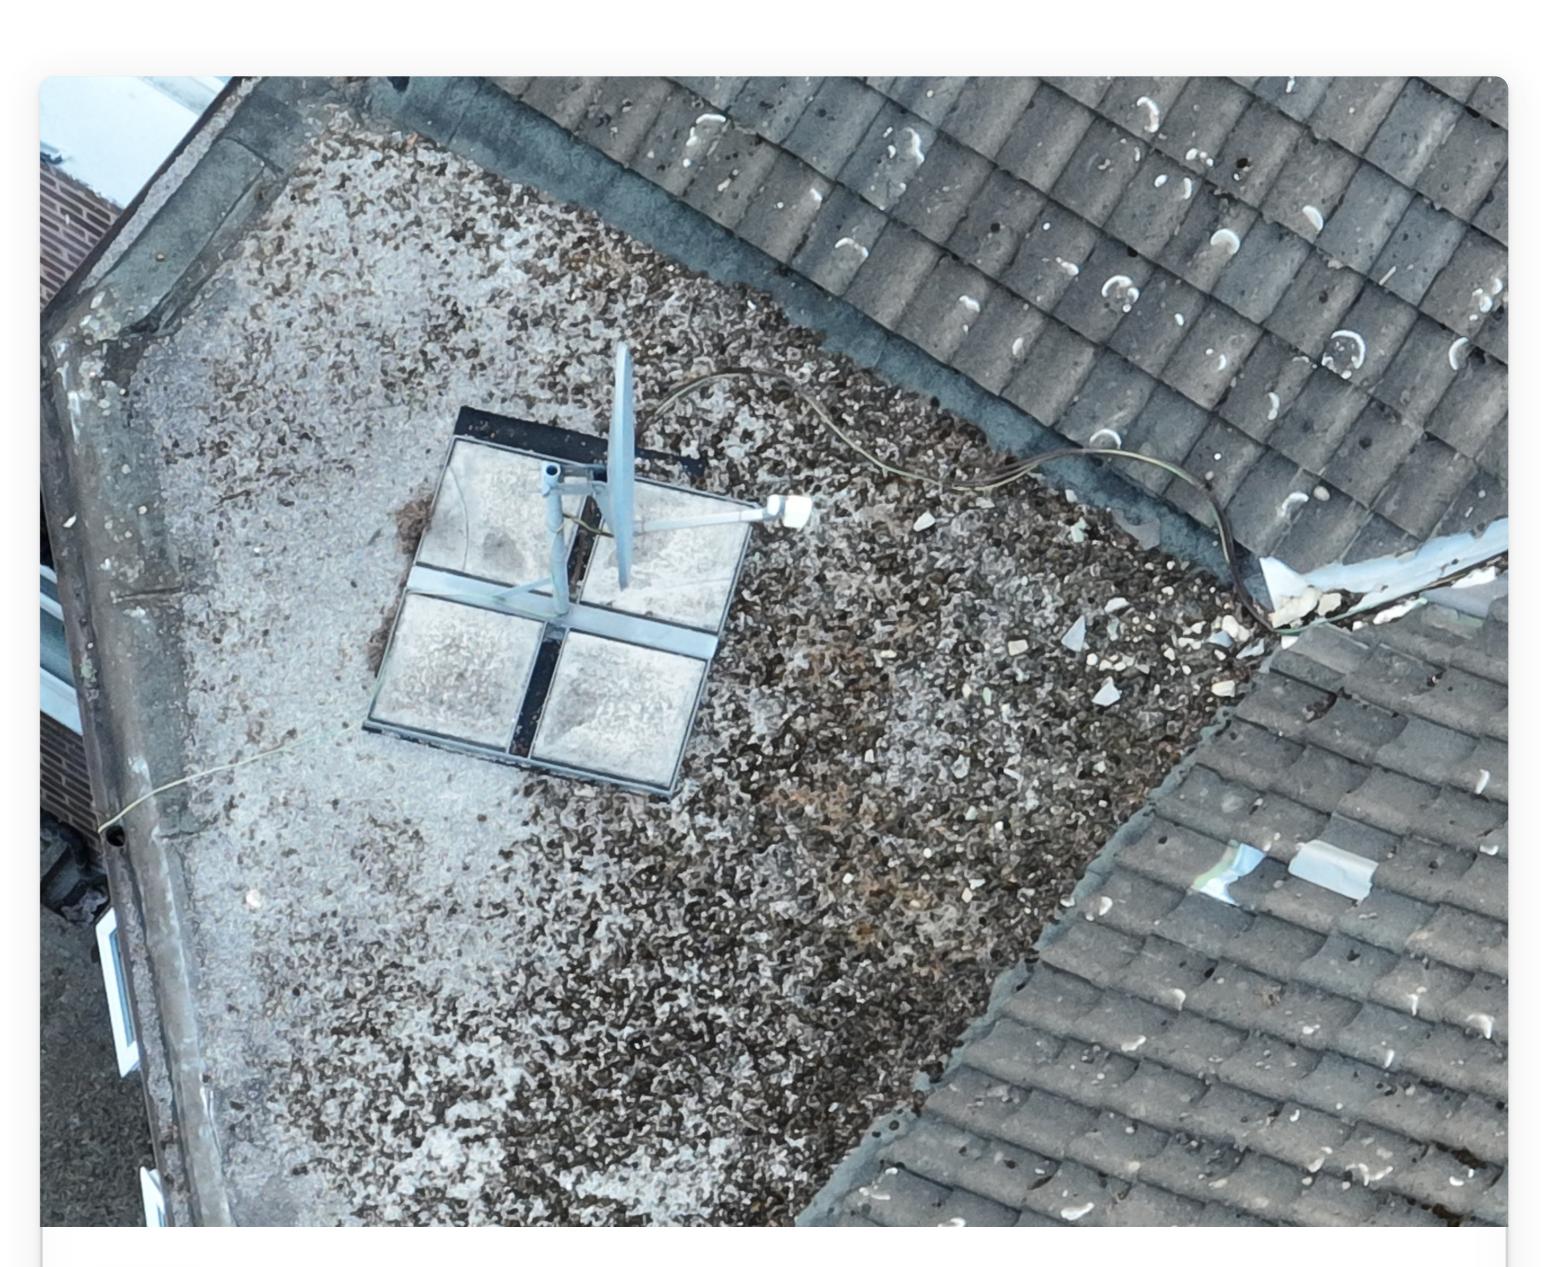
Build up of debris and waste on roof.

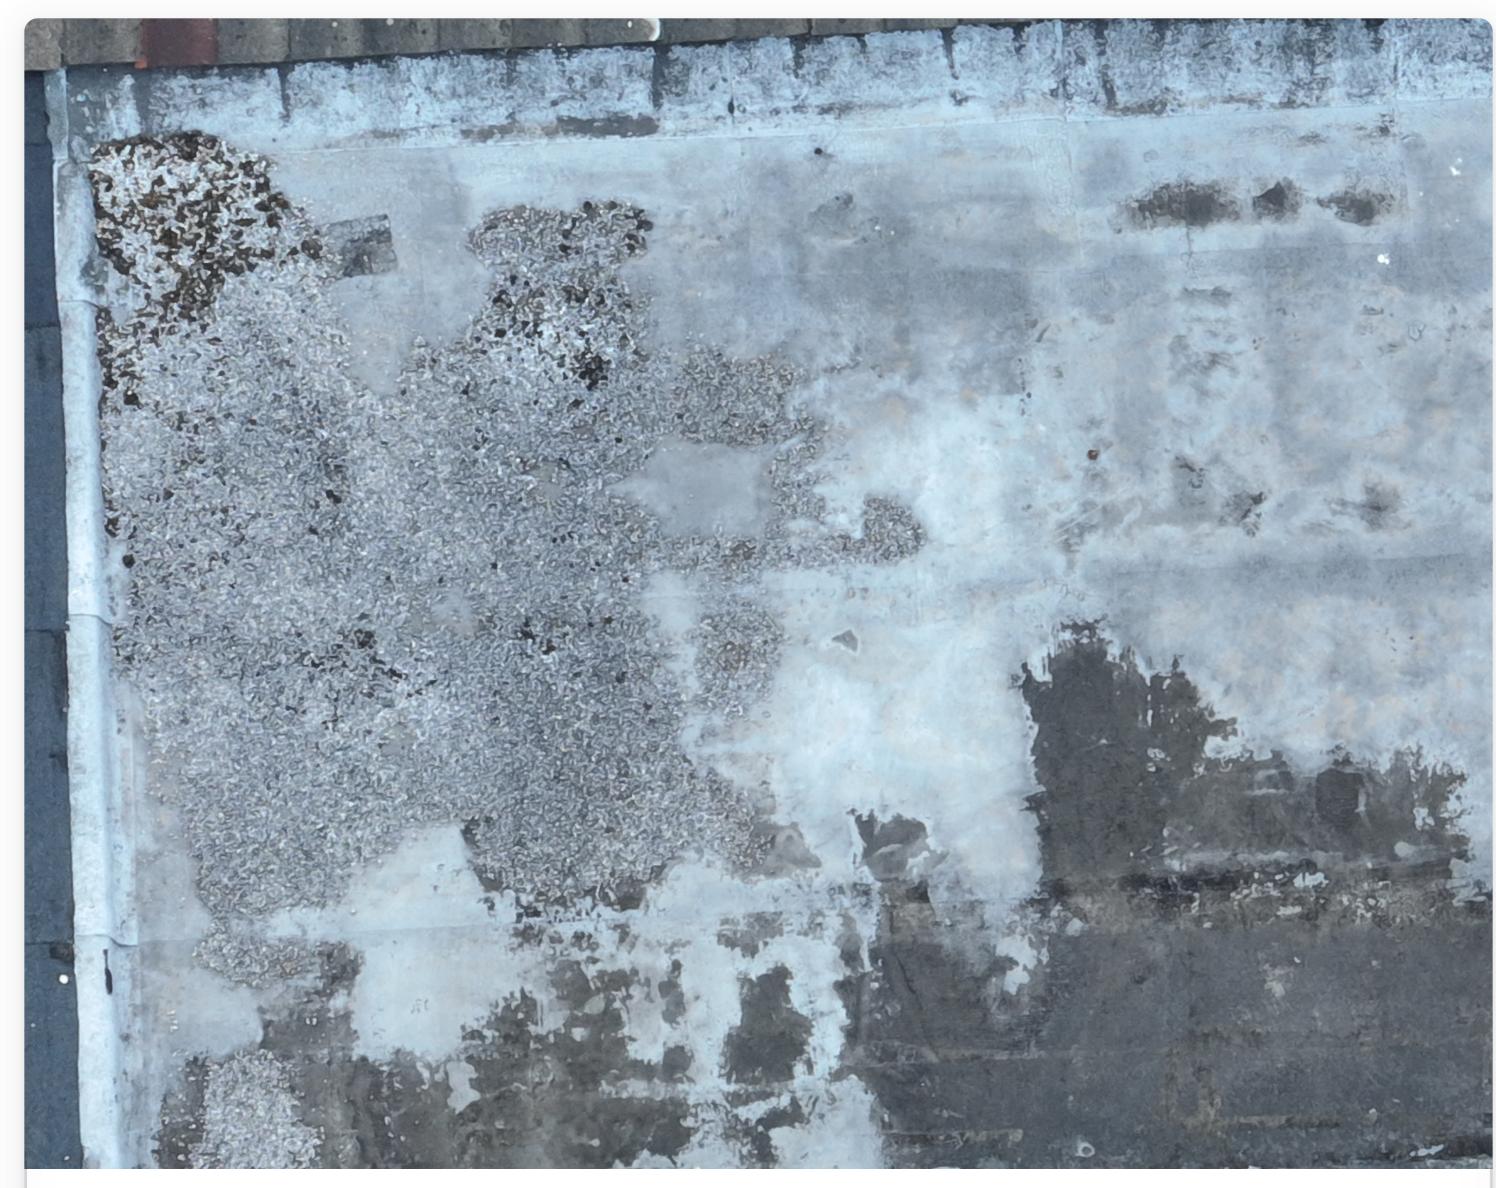
#03

Build up of debris and waste

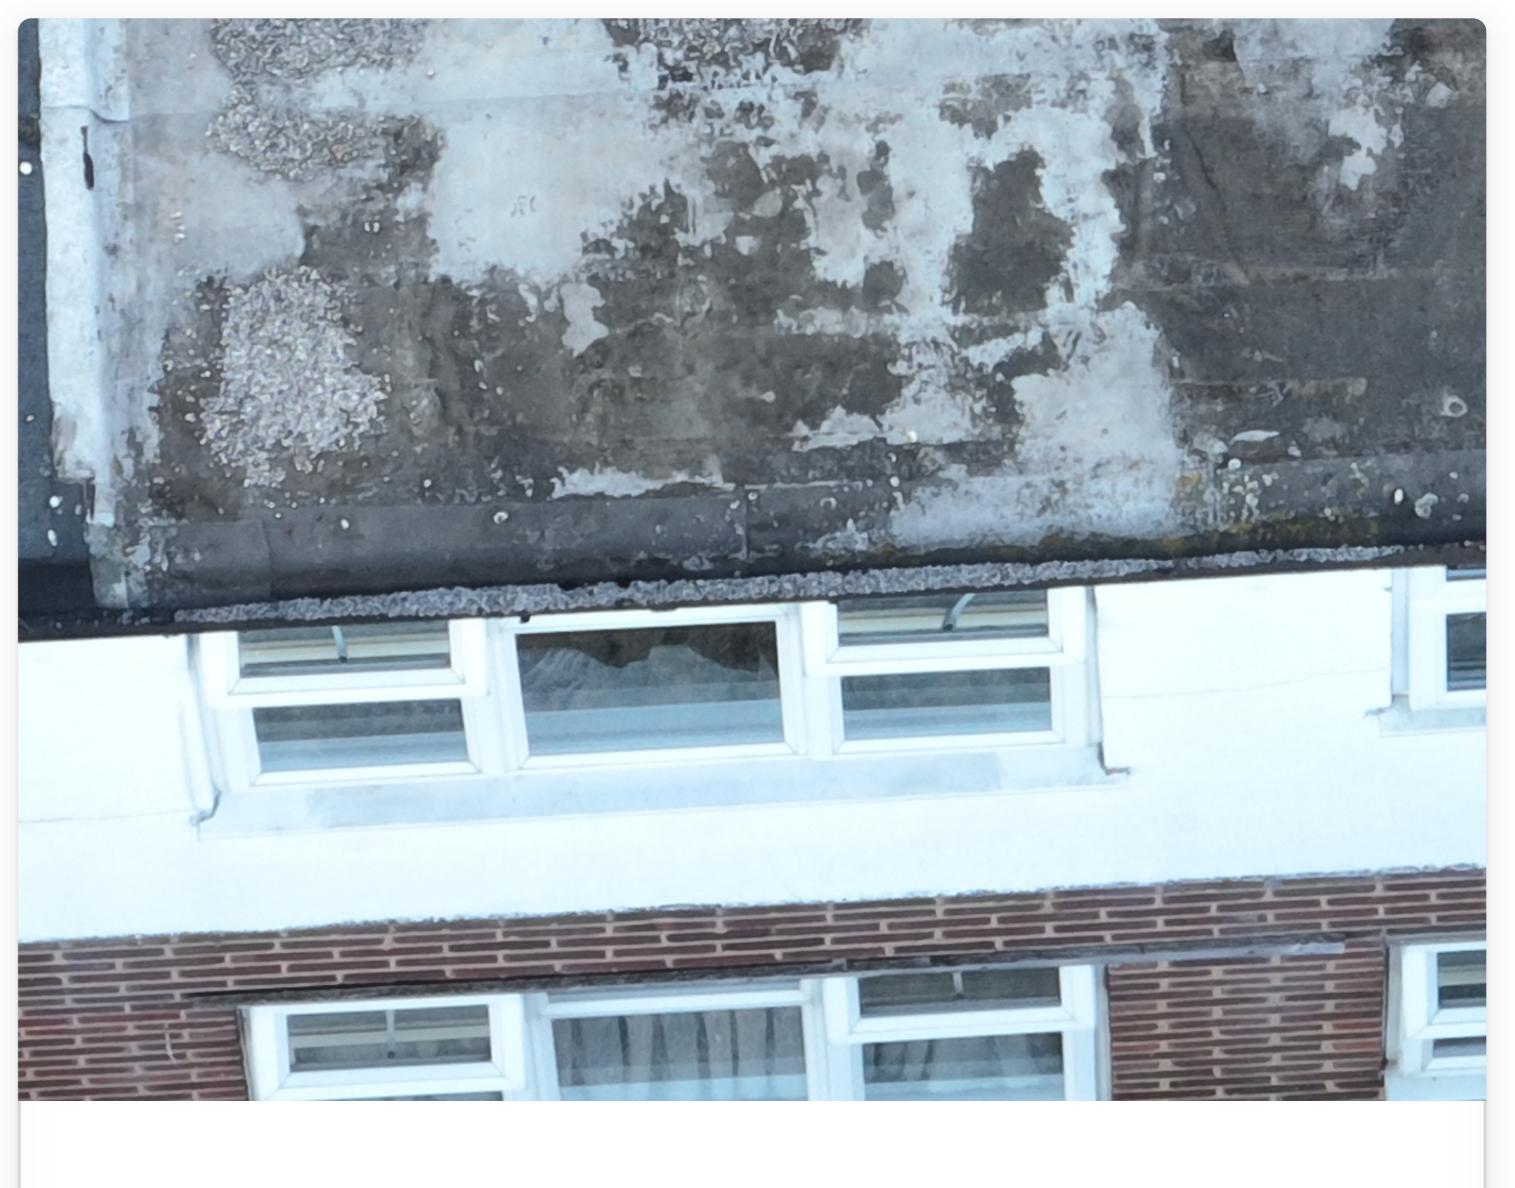
#04

Gutter blockage as a result of debris and waste. Requires cleaning of gutter

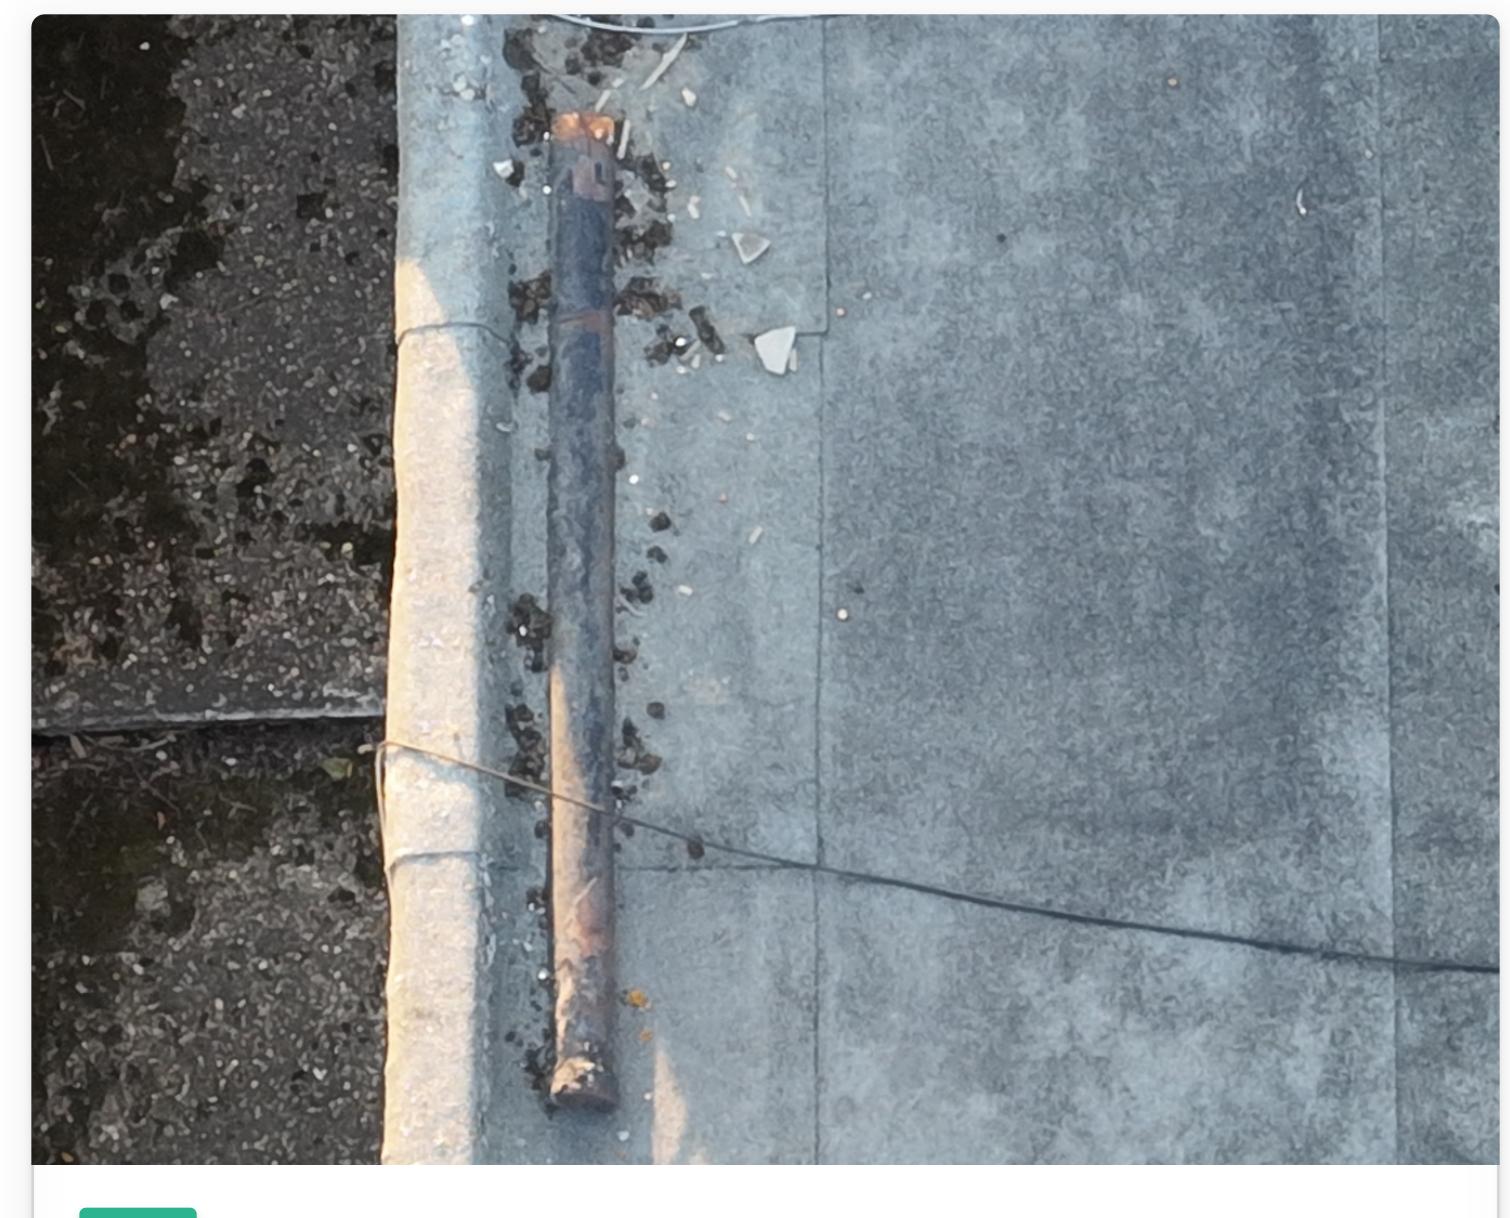
Discard cast iron pipe left on roof

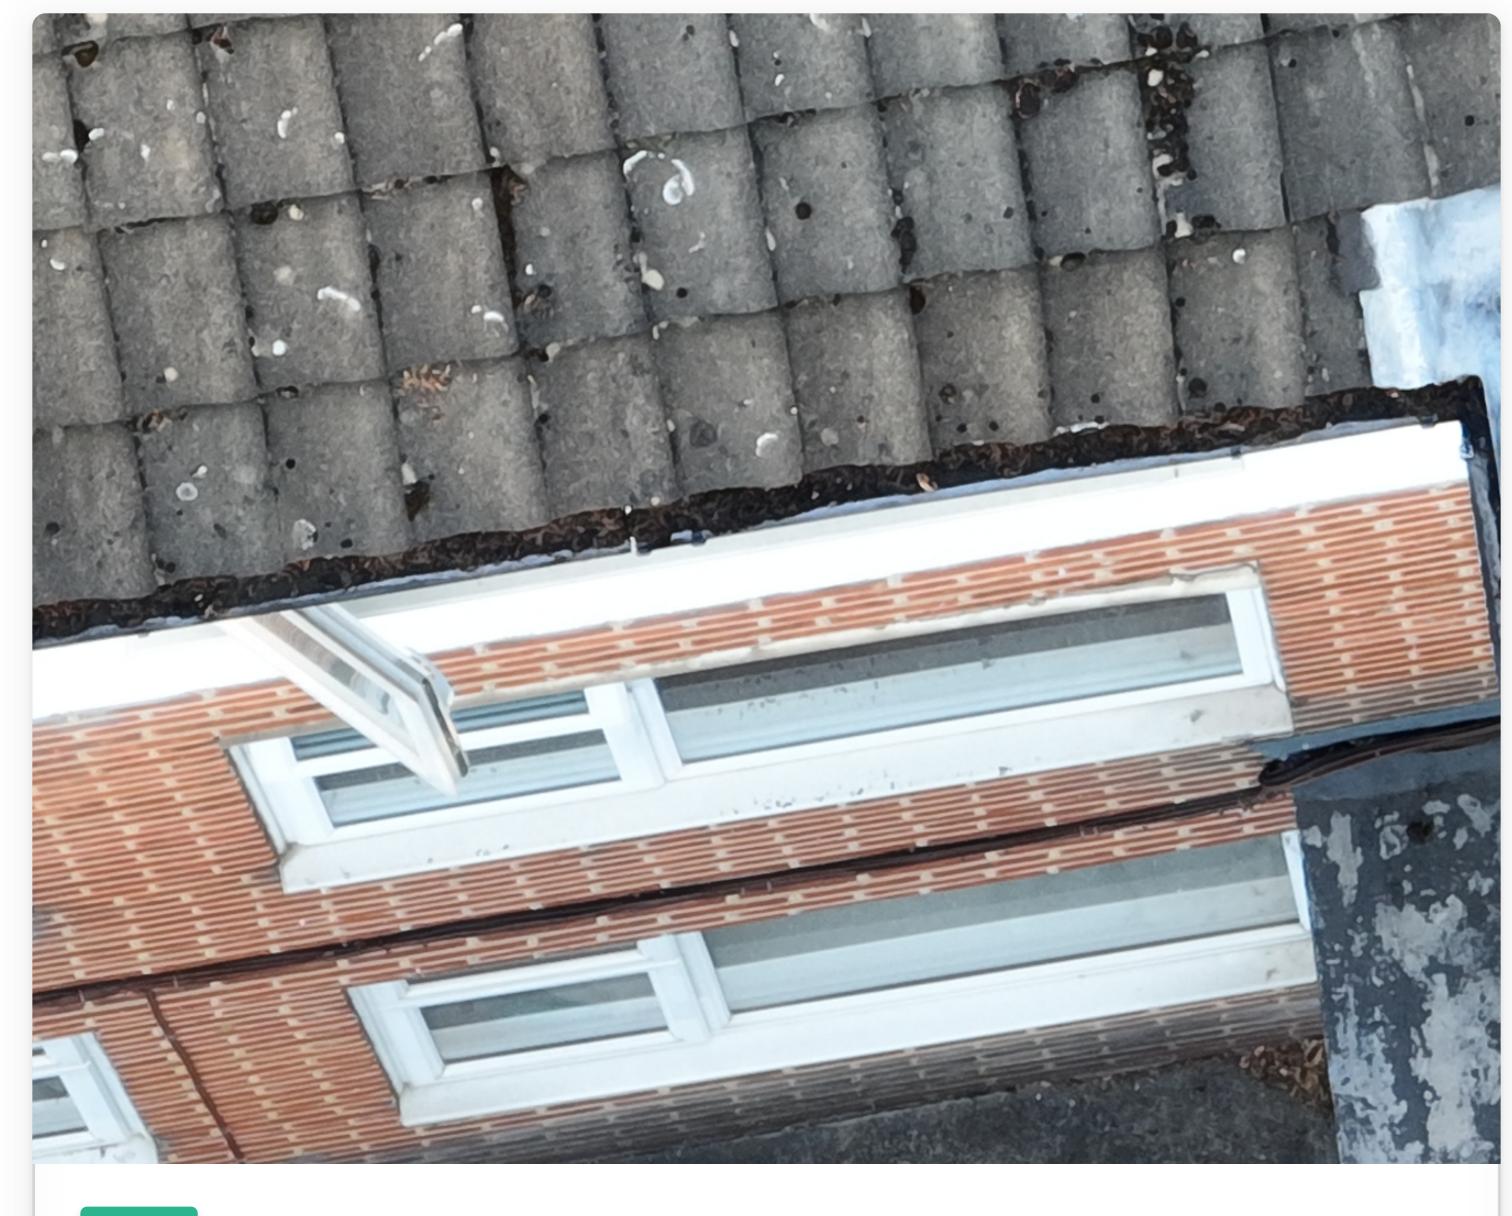
#06

Gutter blockage as a result of waste and debris build up

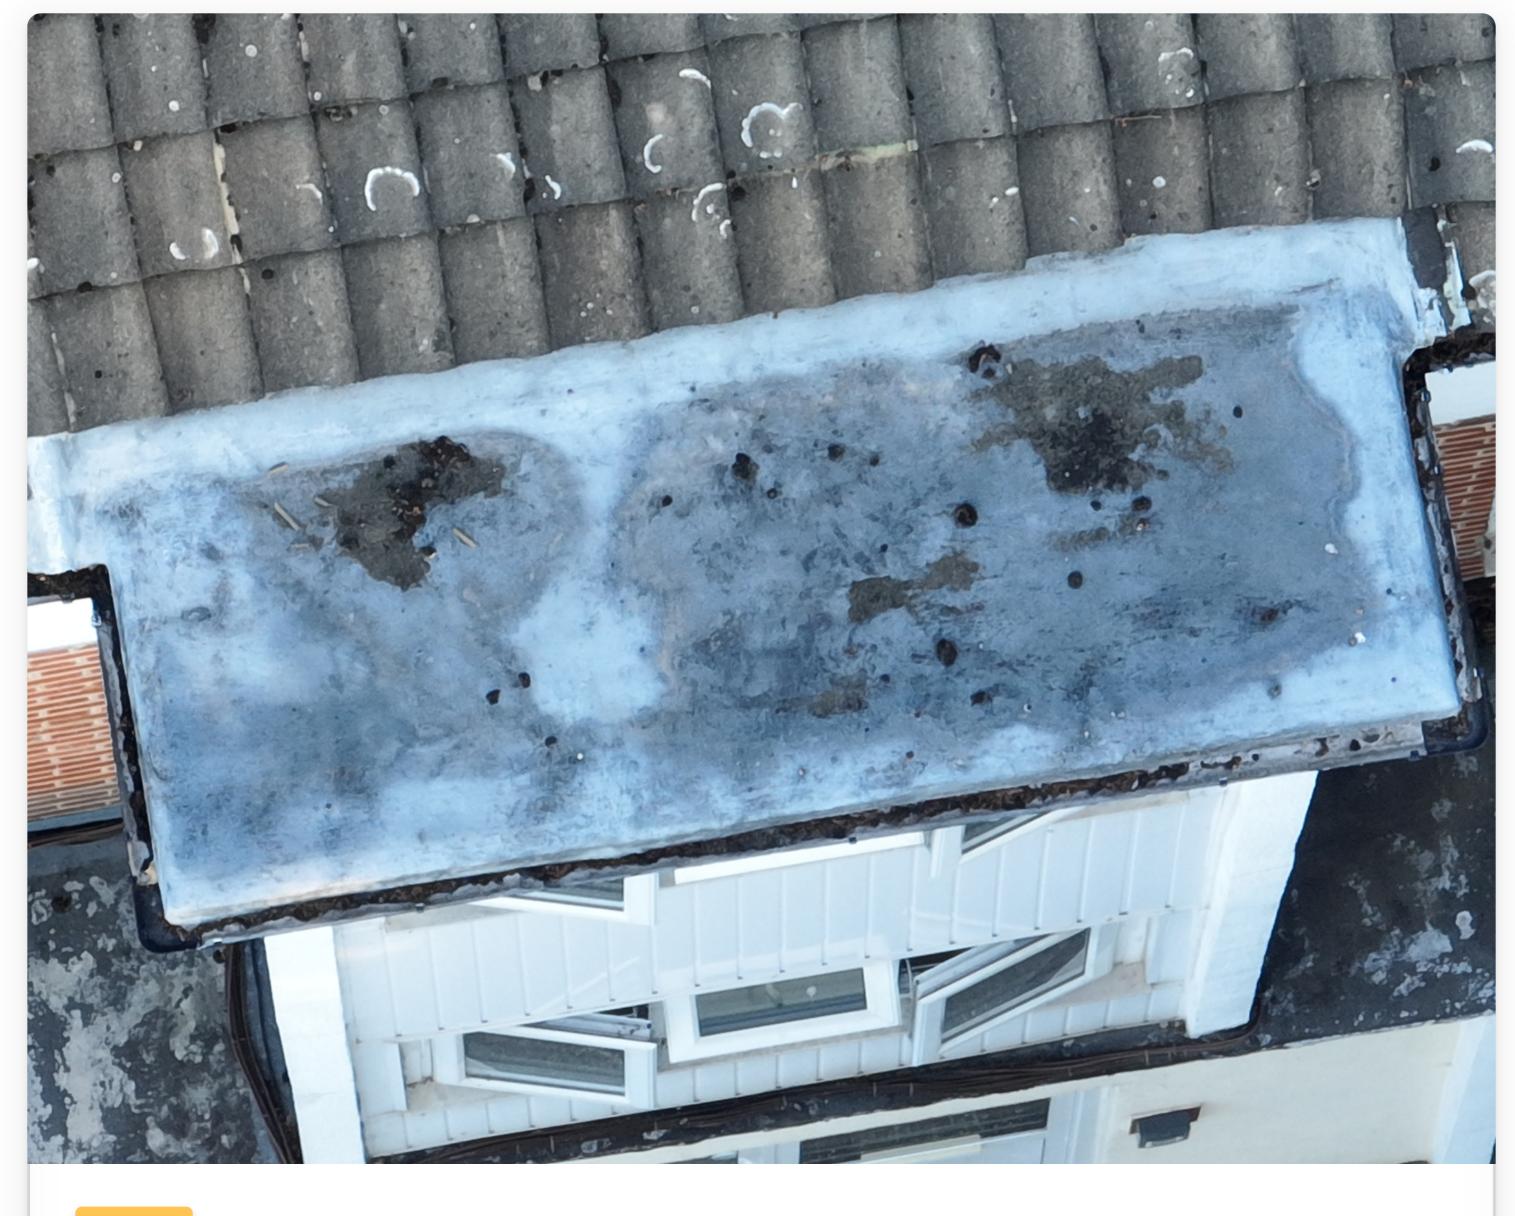
#07

Unlevel surface causing rain water ponding
