## Roof Survey Report

Maynard Point

20th March 2022

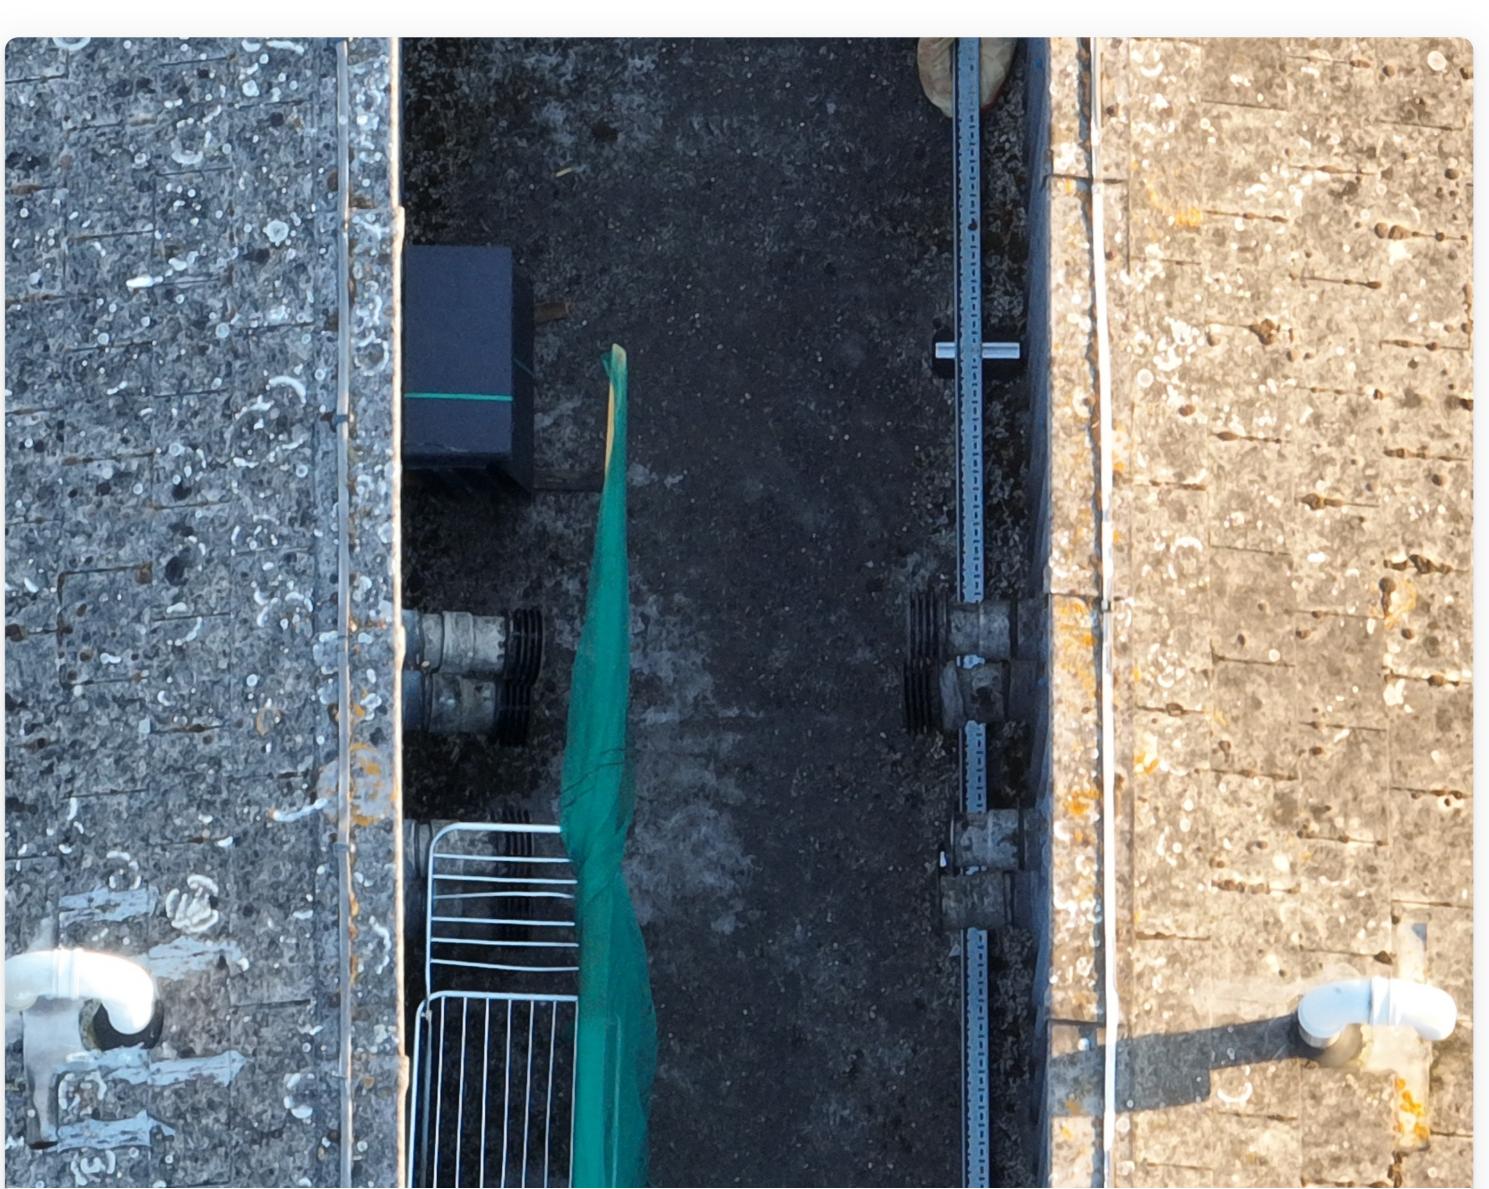
#04
Discarded waste on the roof

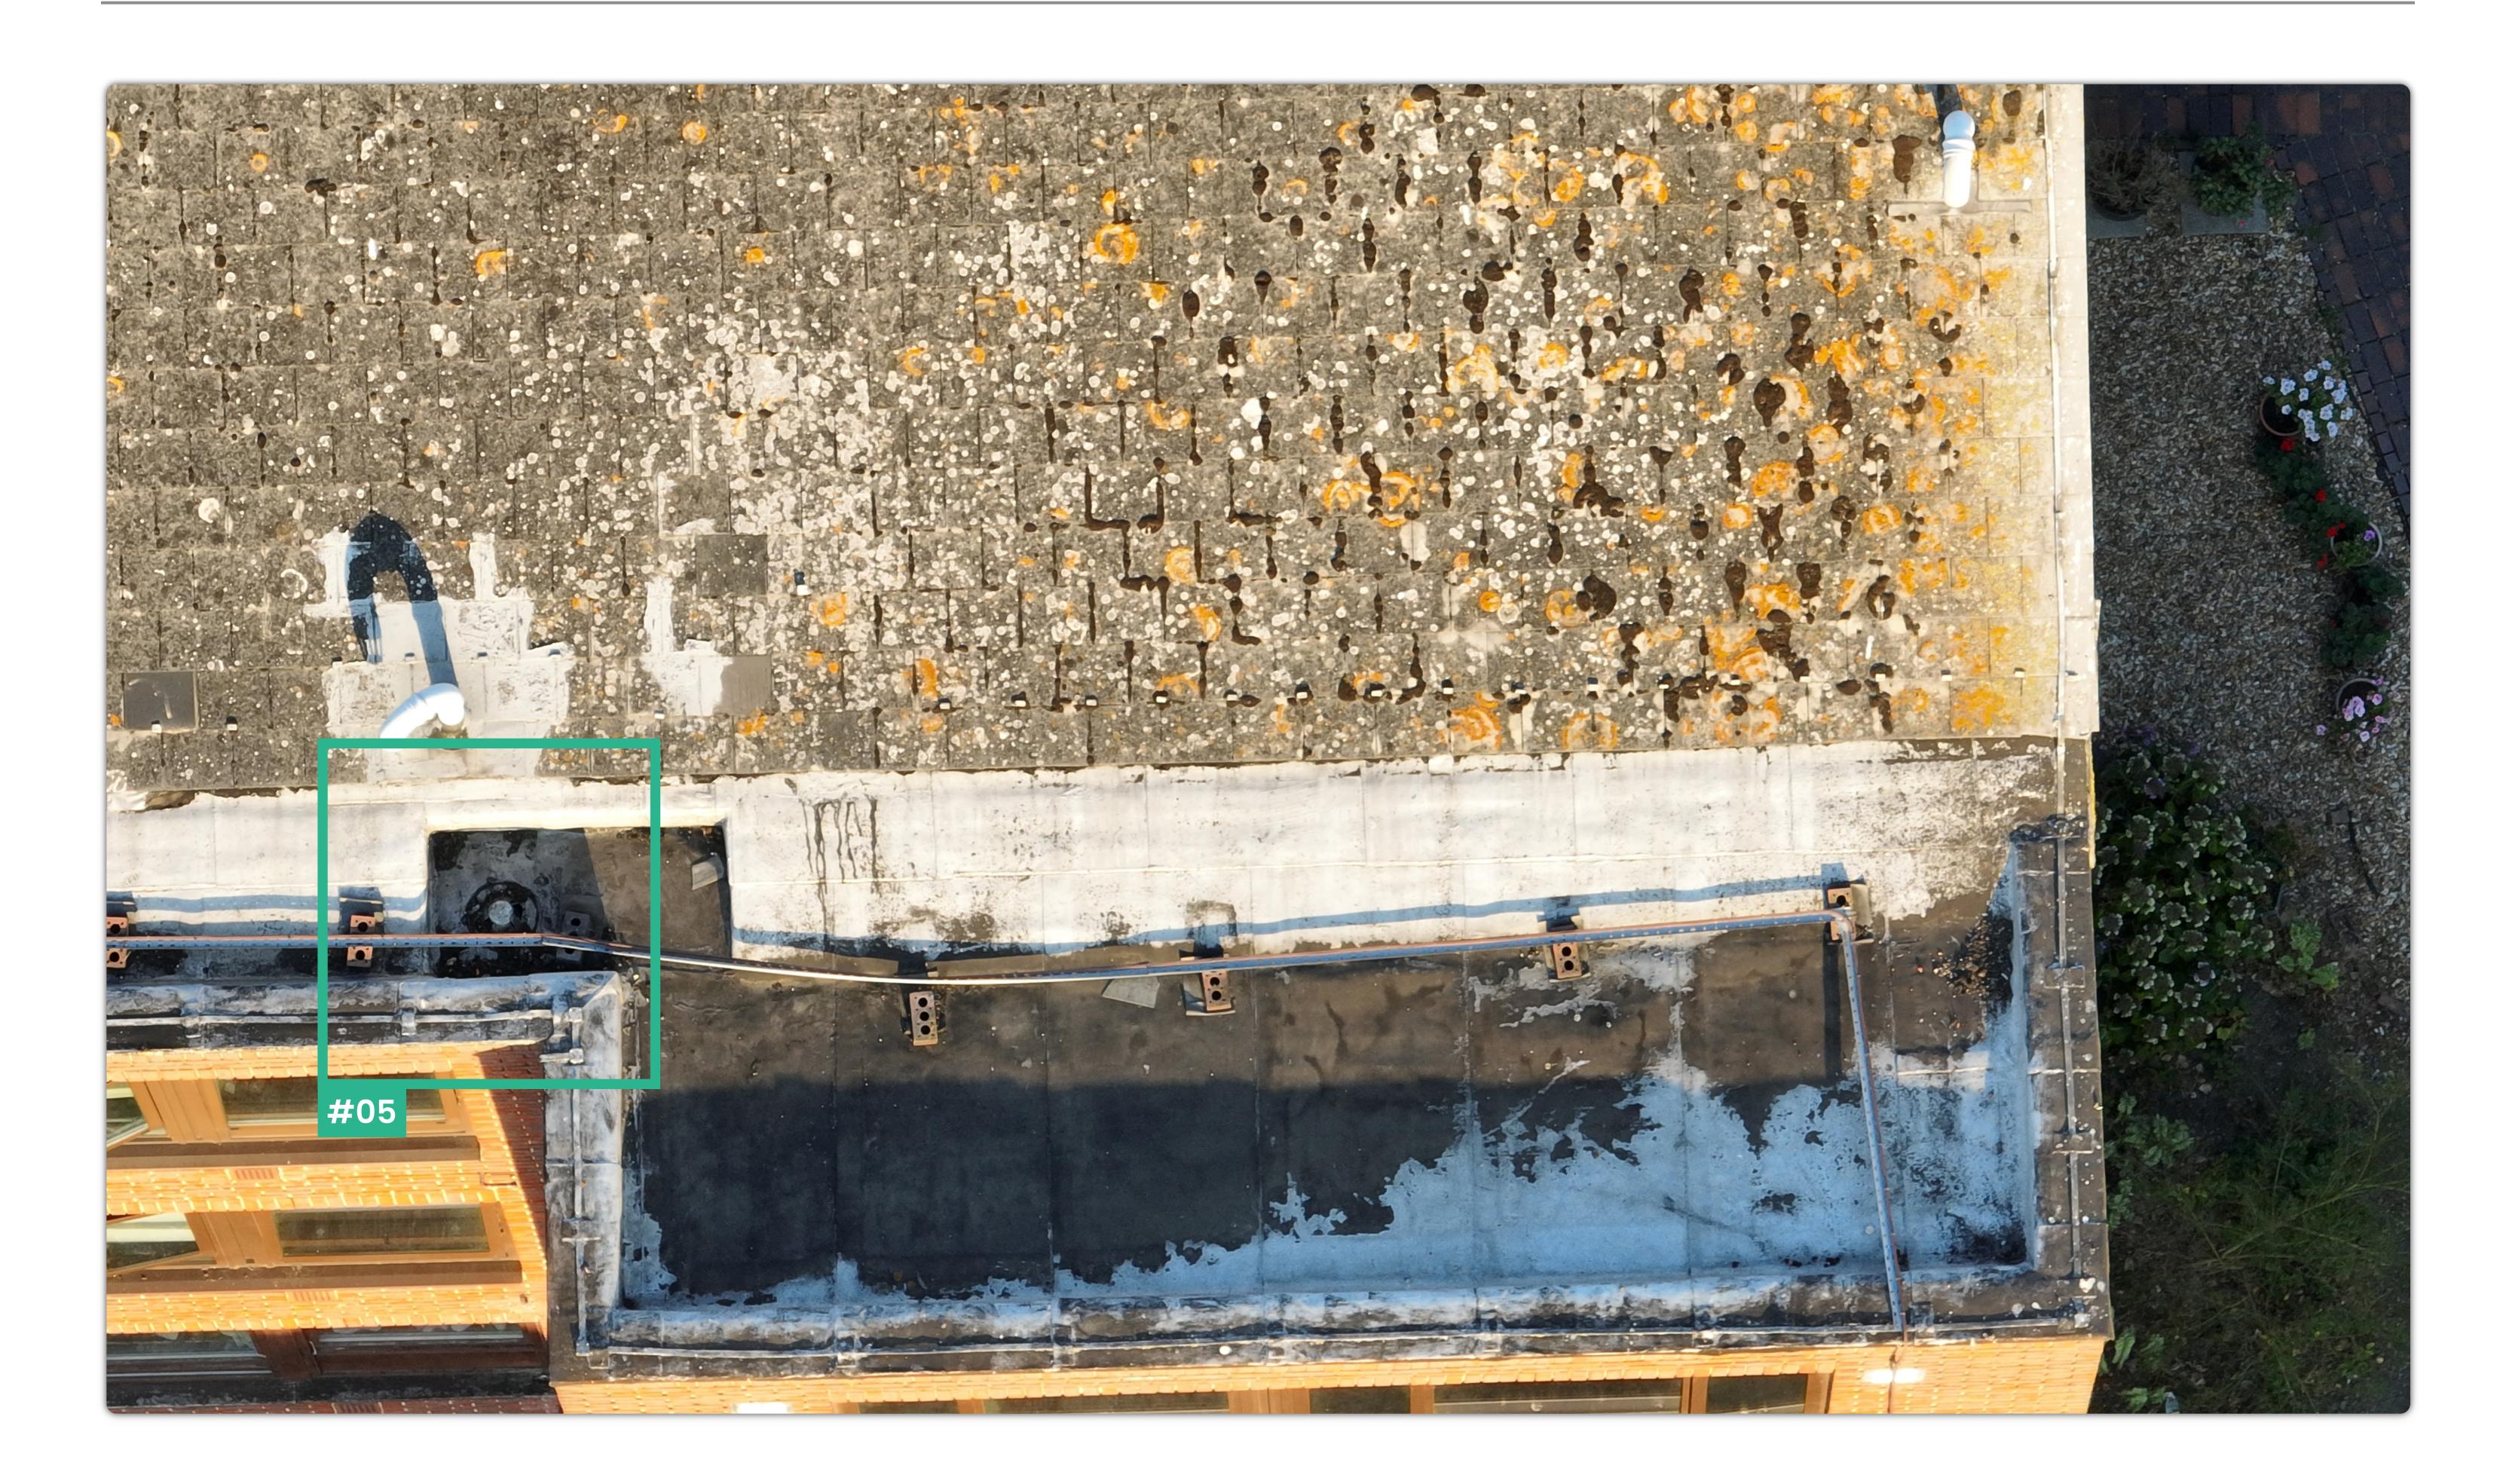
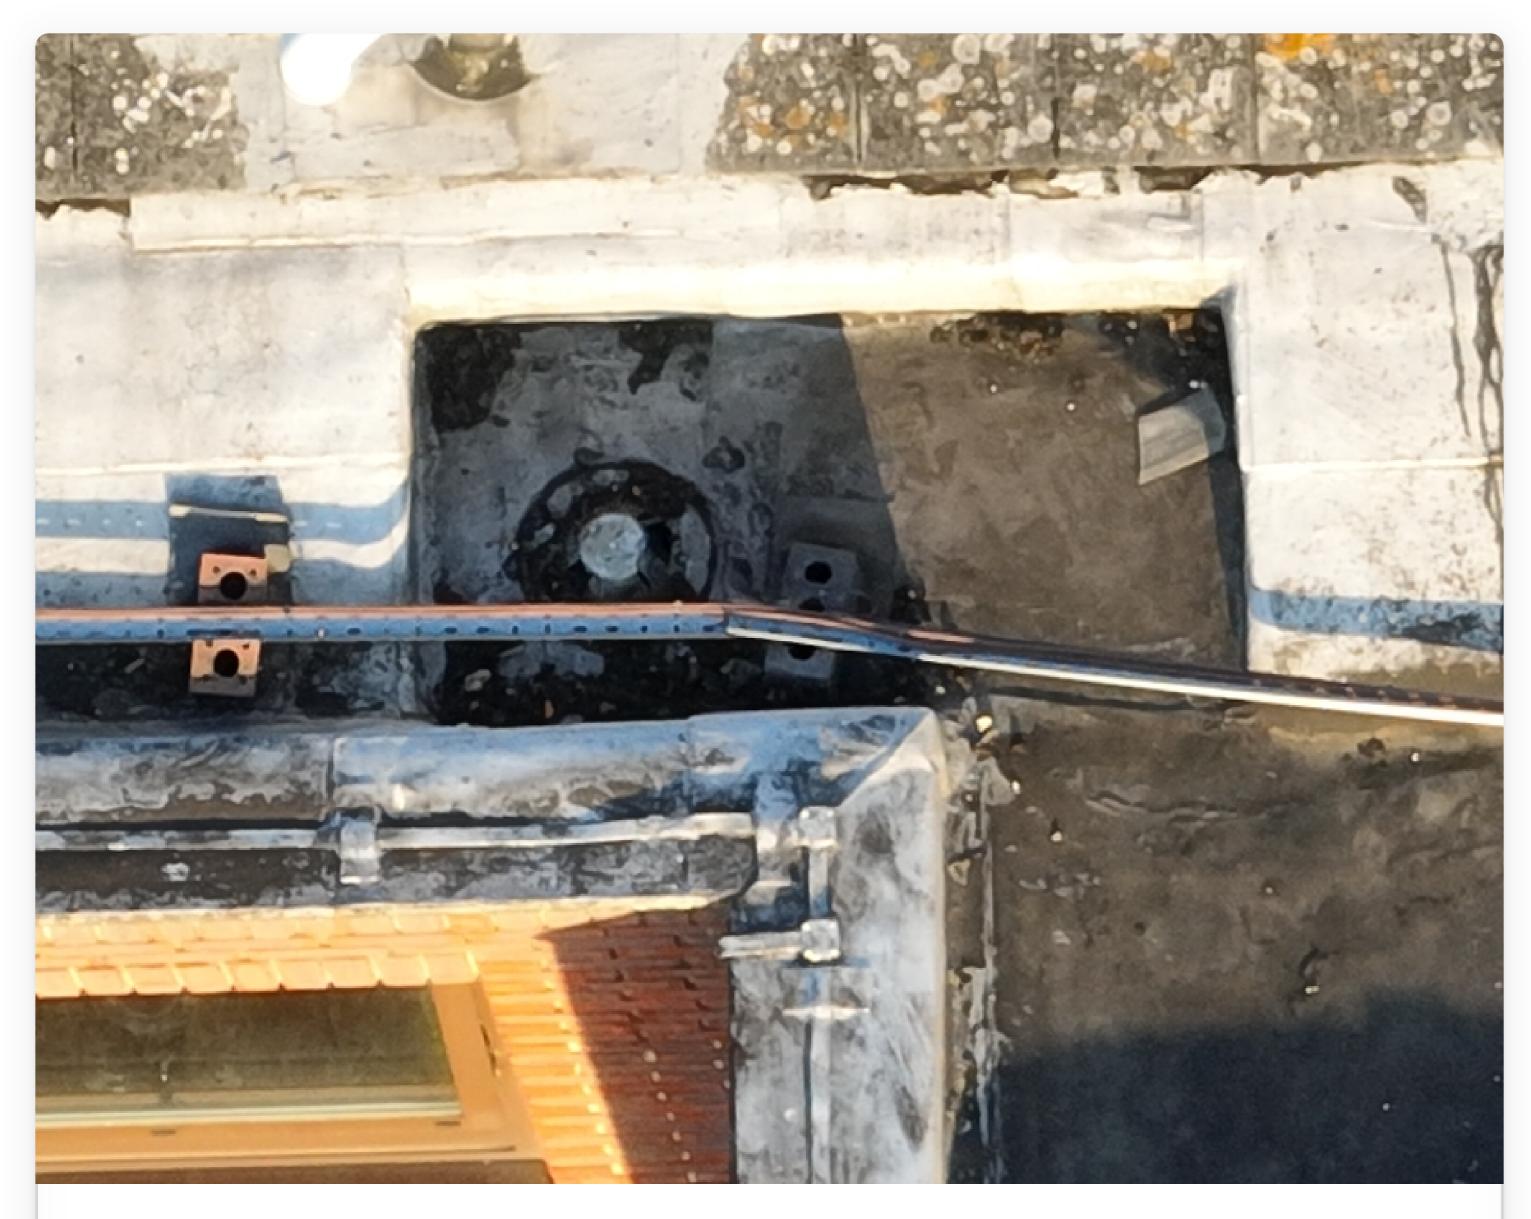
#05

Waste building up around gutter grill. Requires cleaning

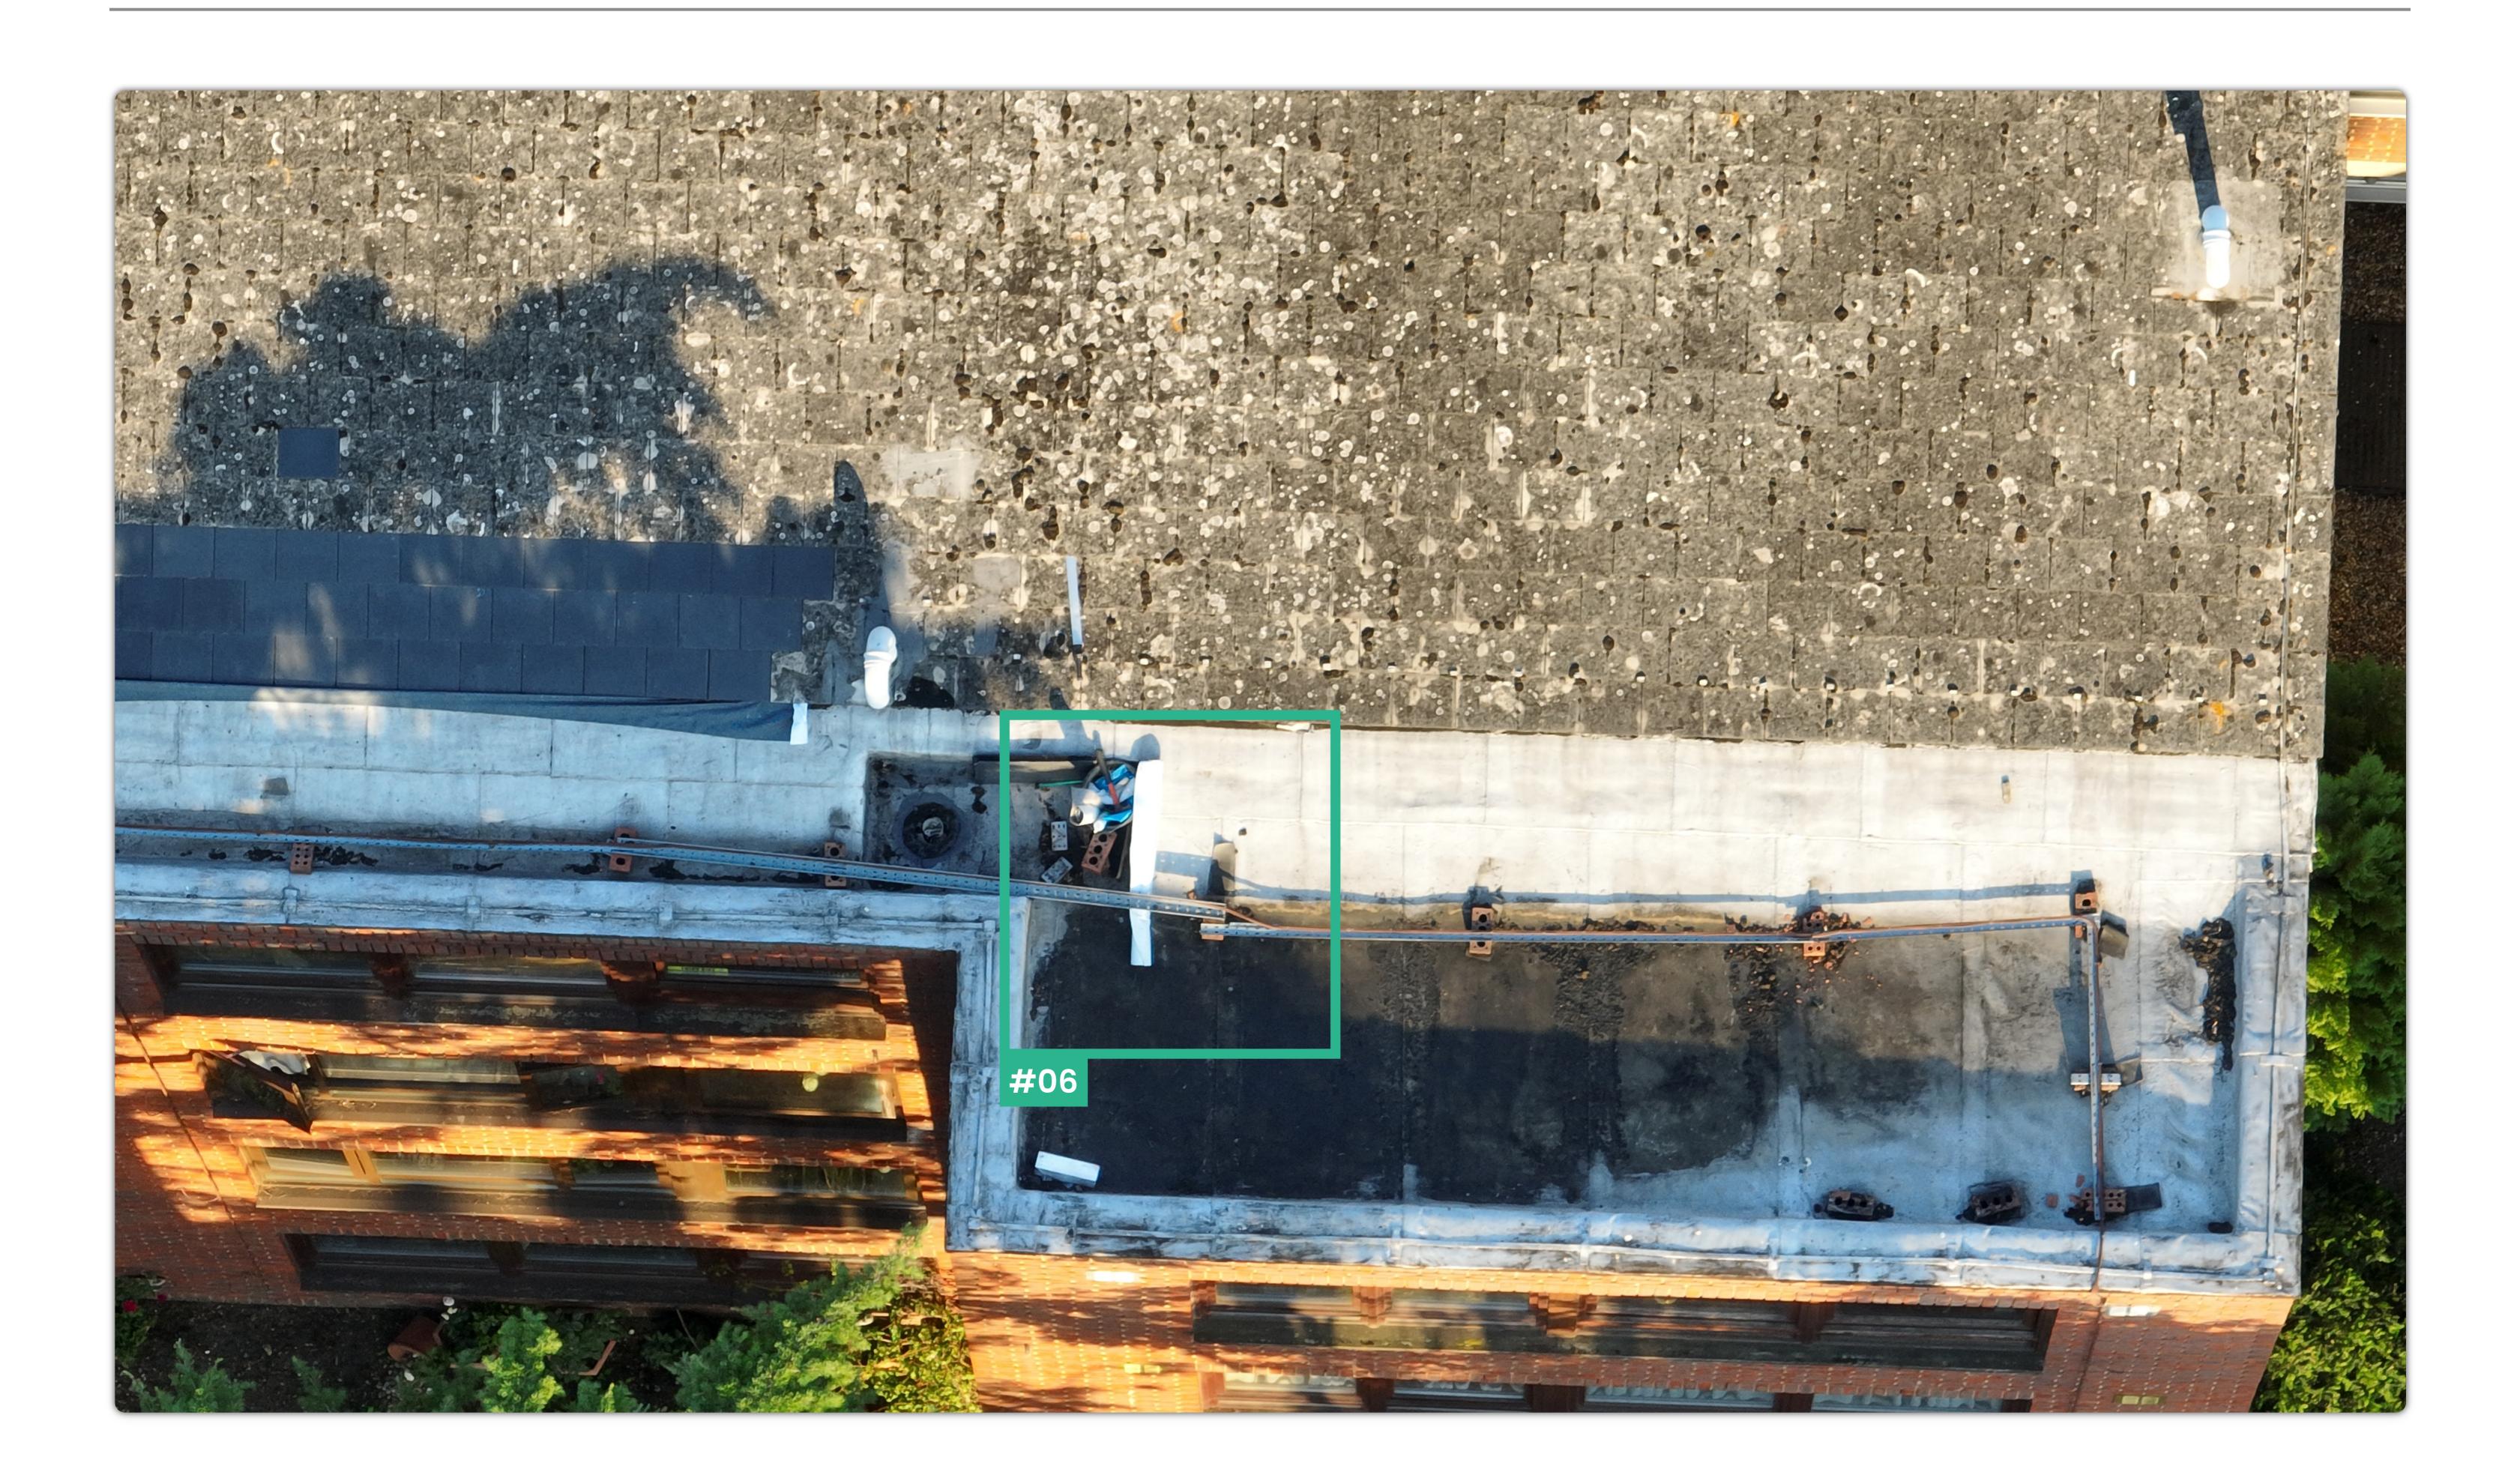
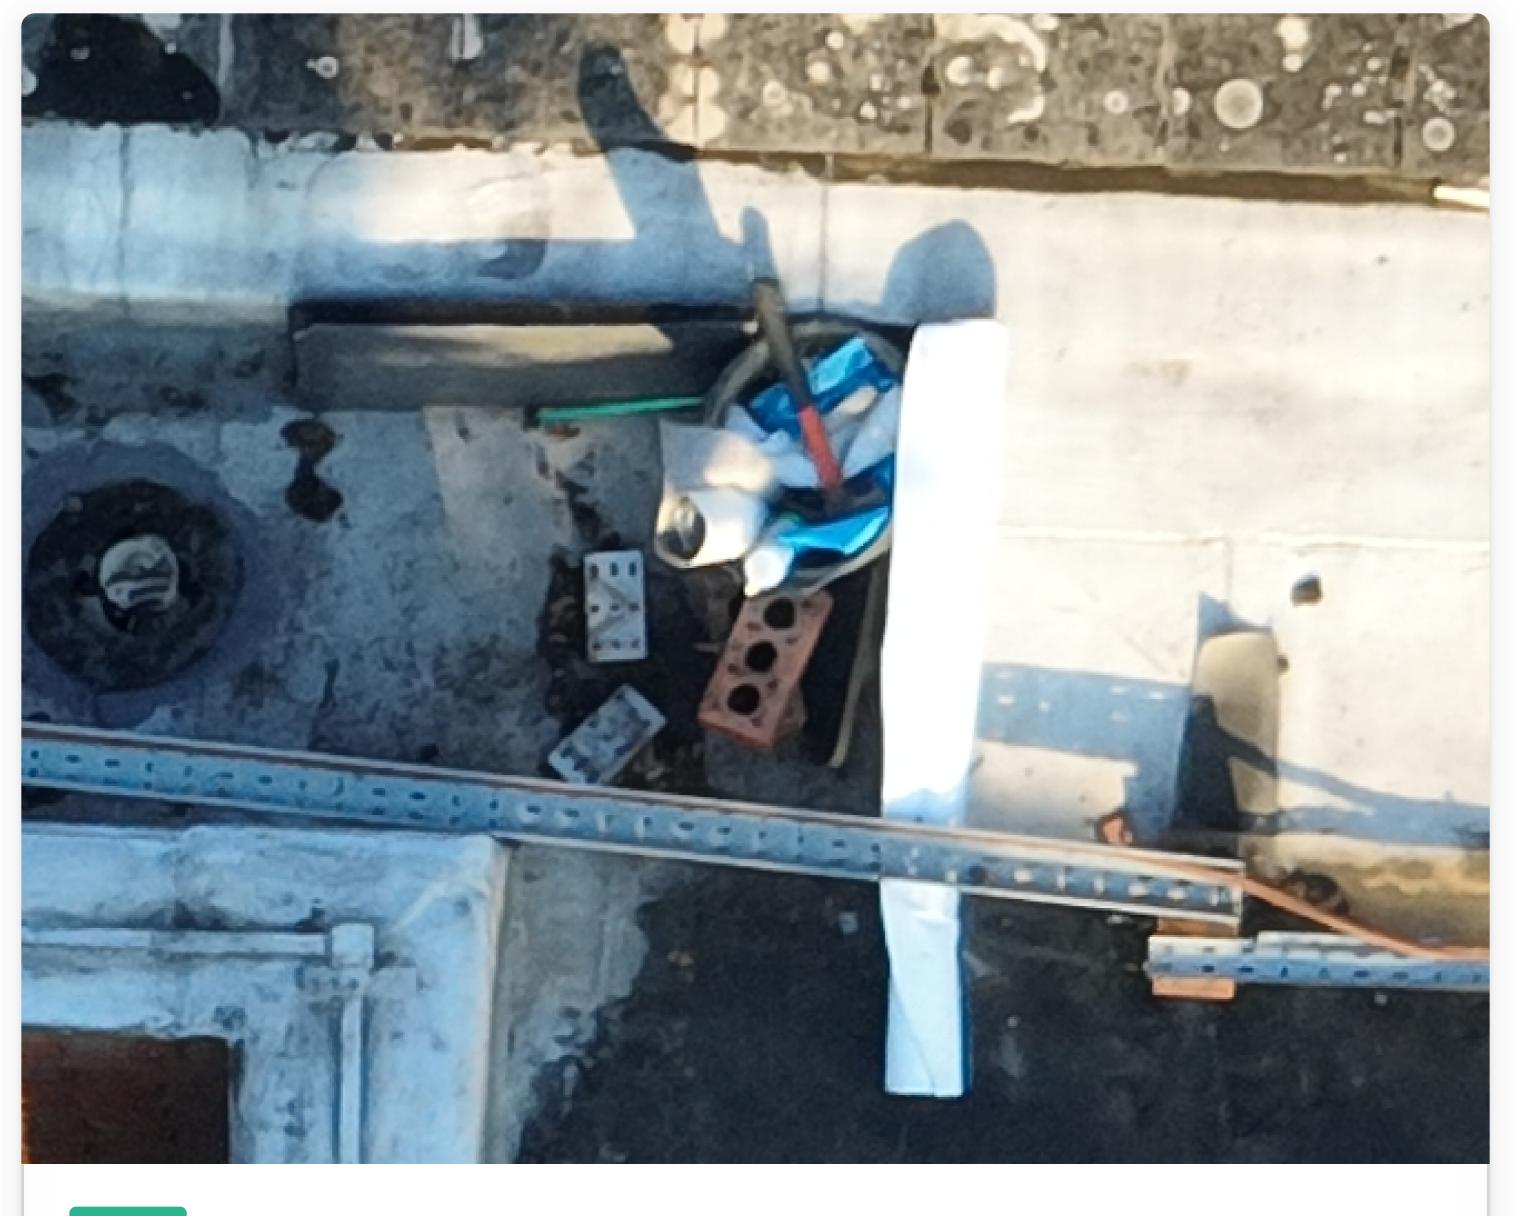
#06

Discarded waste on the roof
