Frame Bound Surveys

Roof Survey Report

Fitness Centre

FSU0006

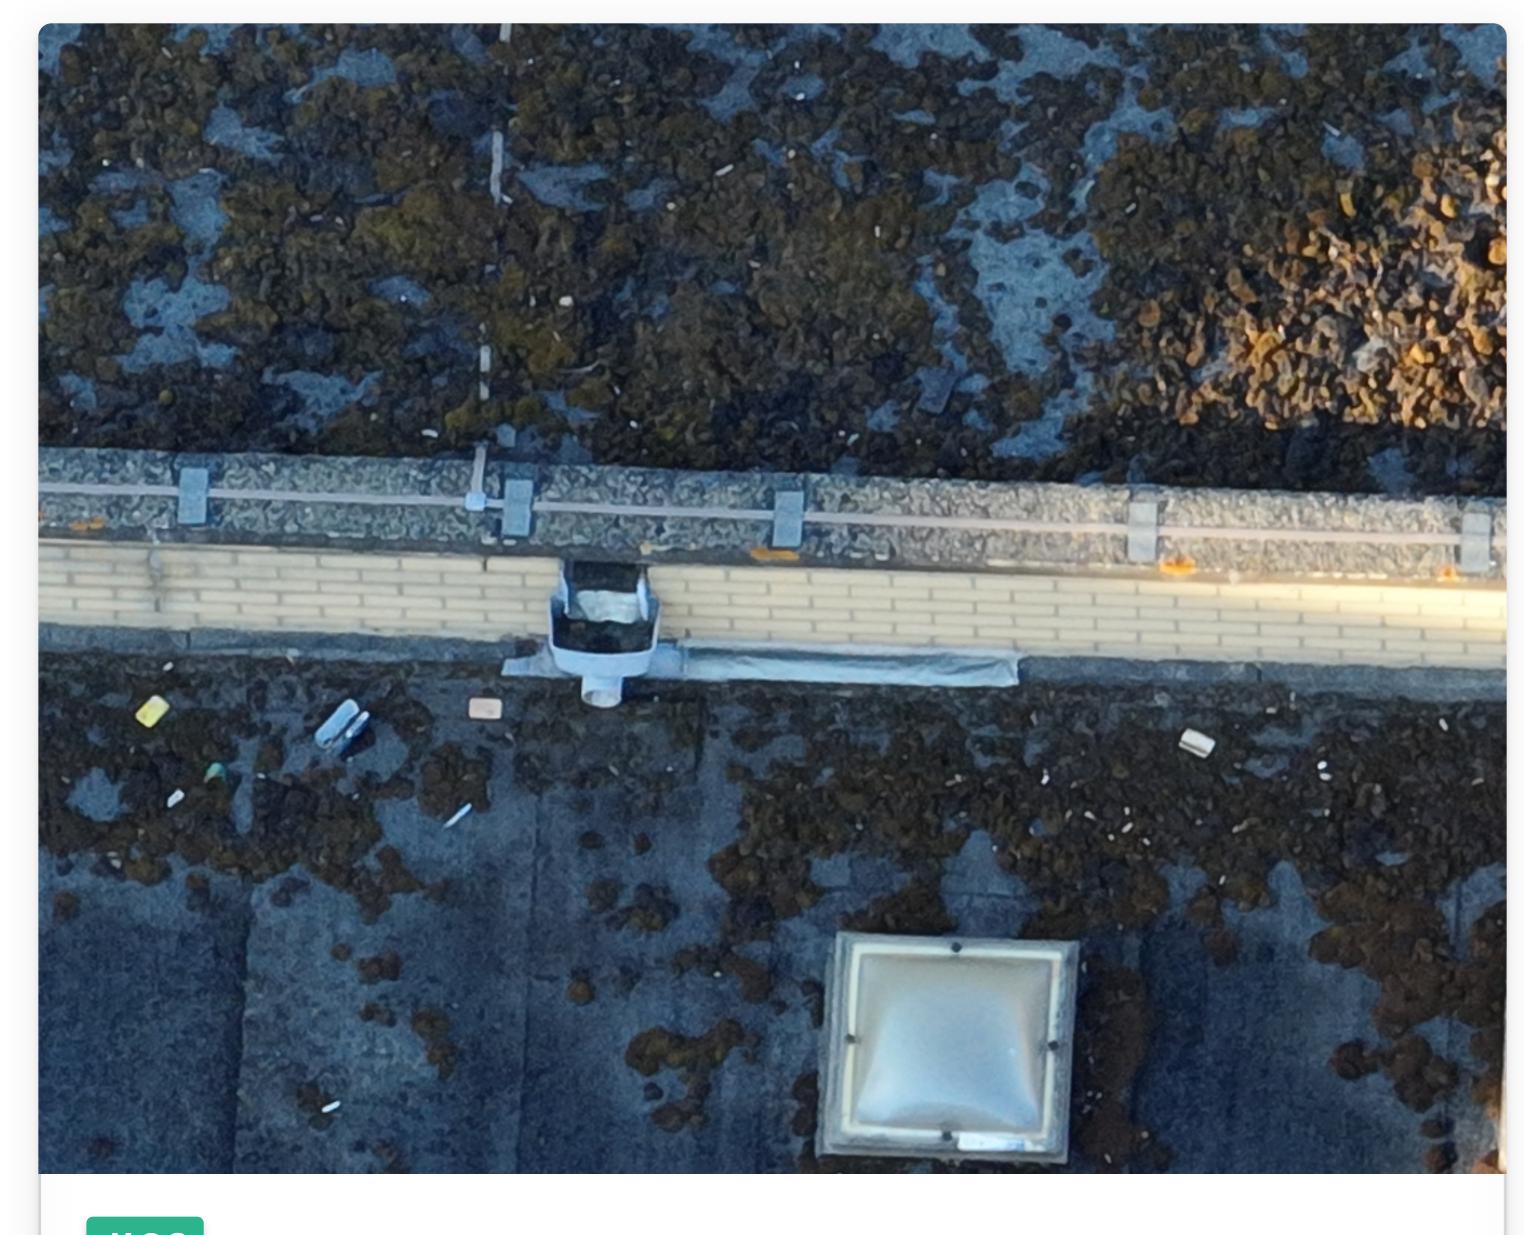
#03

Gutter blockage as a result of waste up

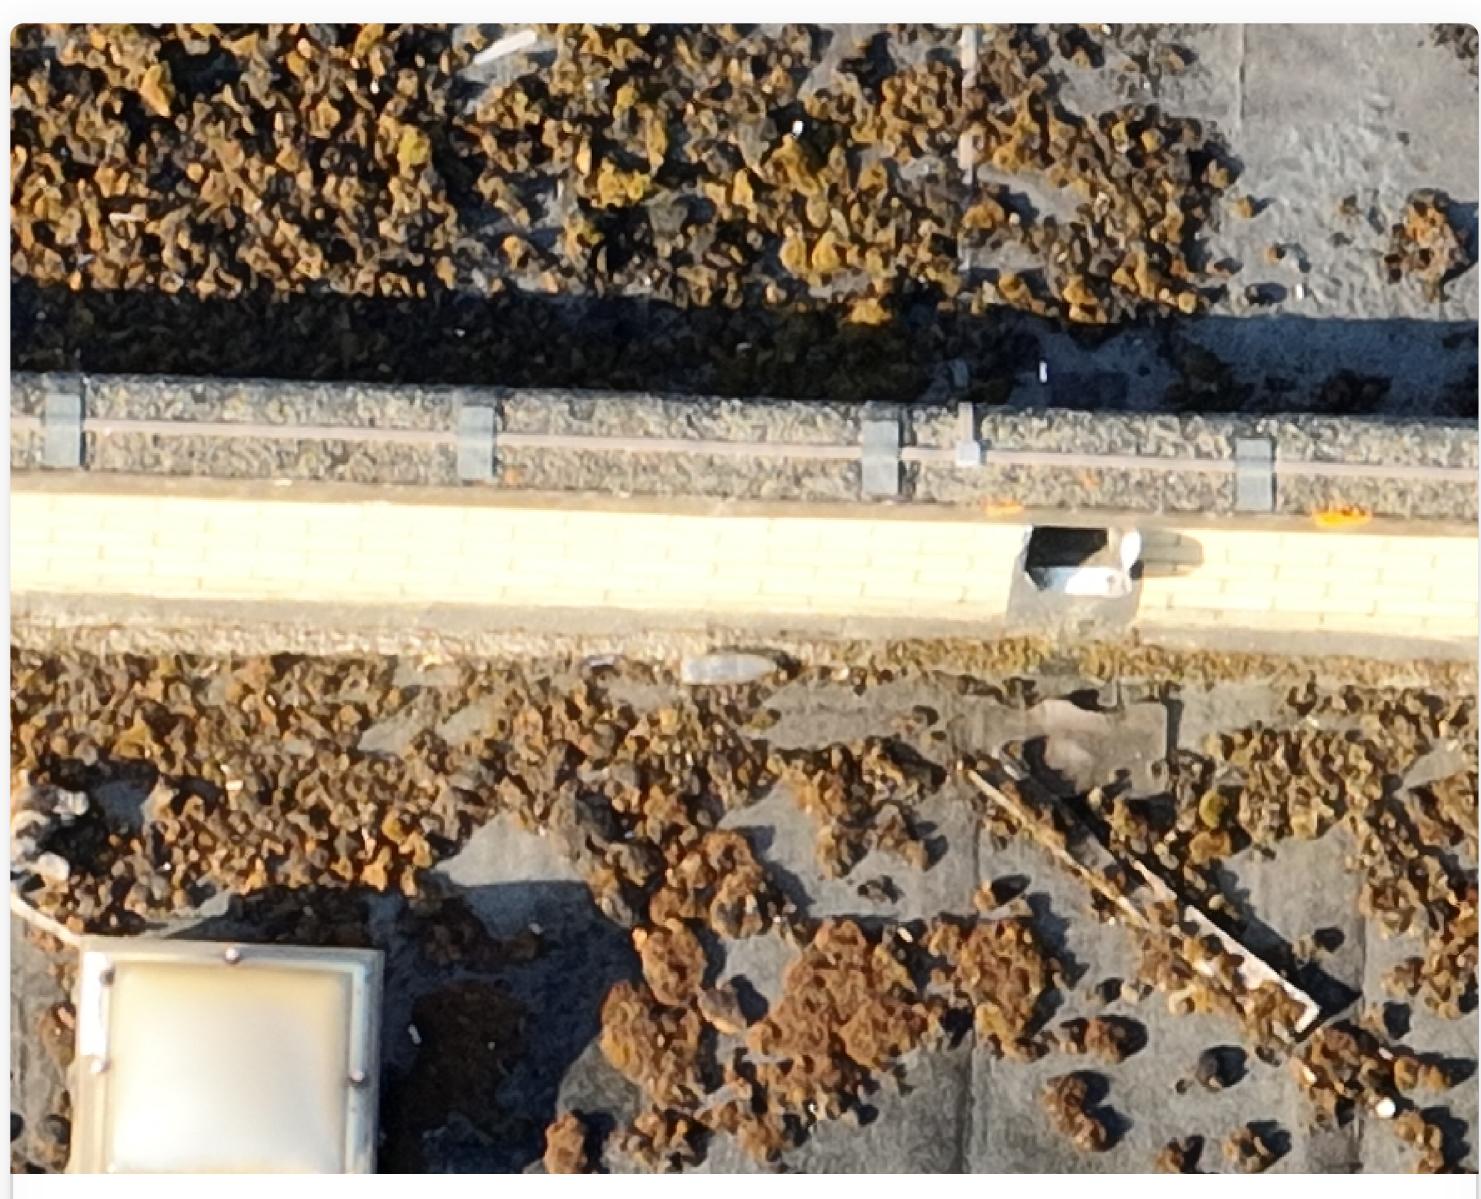
#04

Gutter blockage as a result of waste up

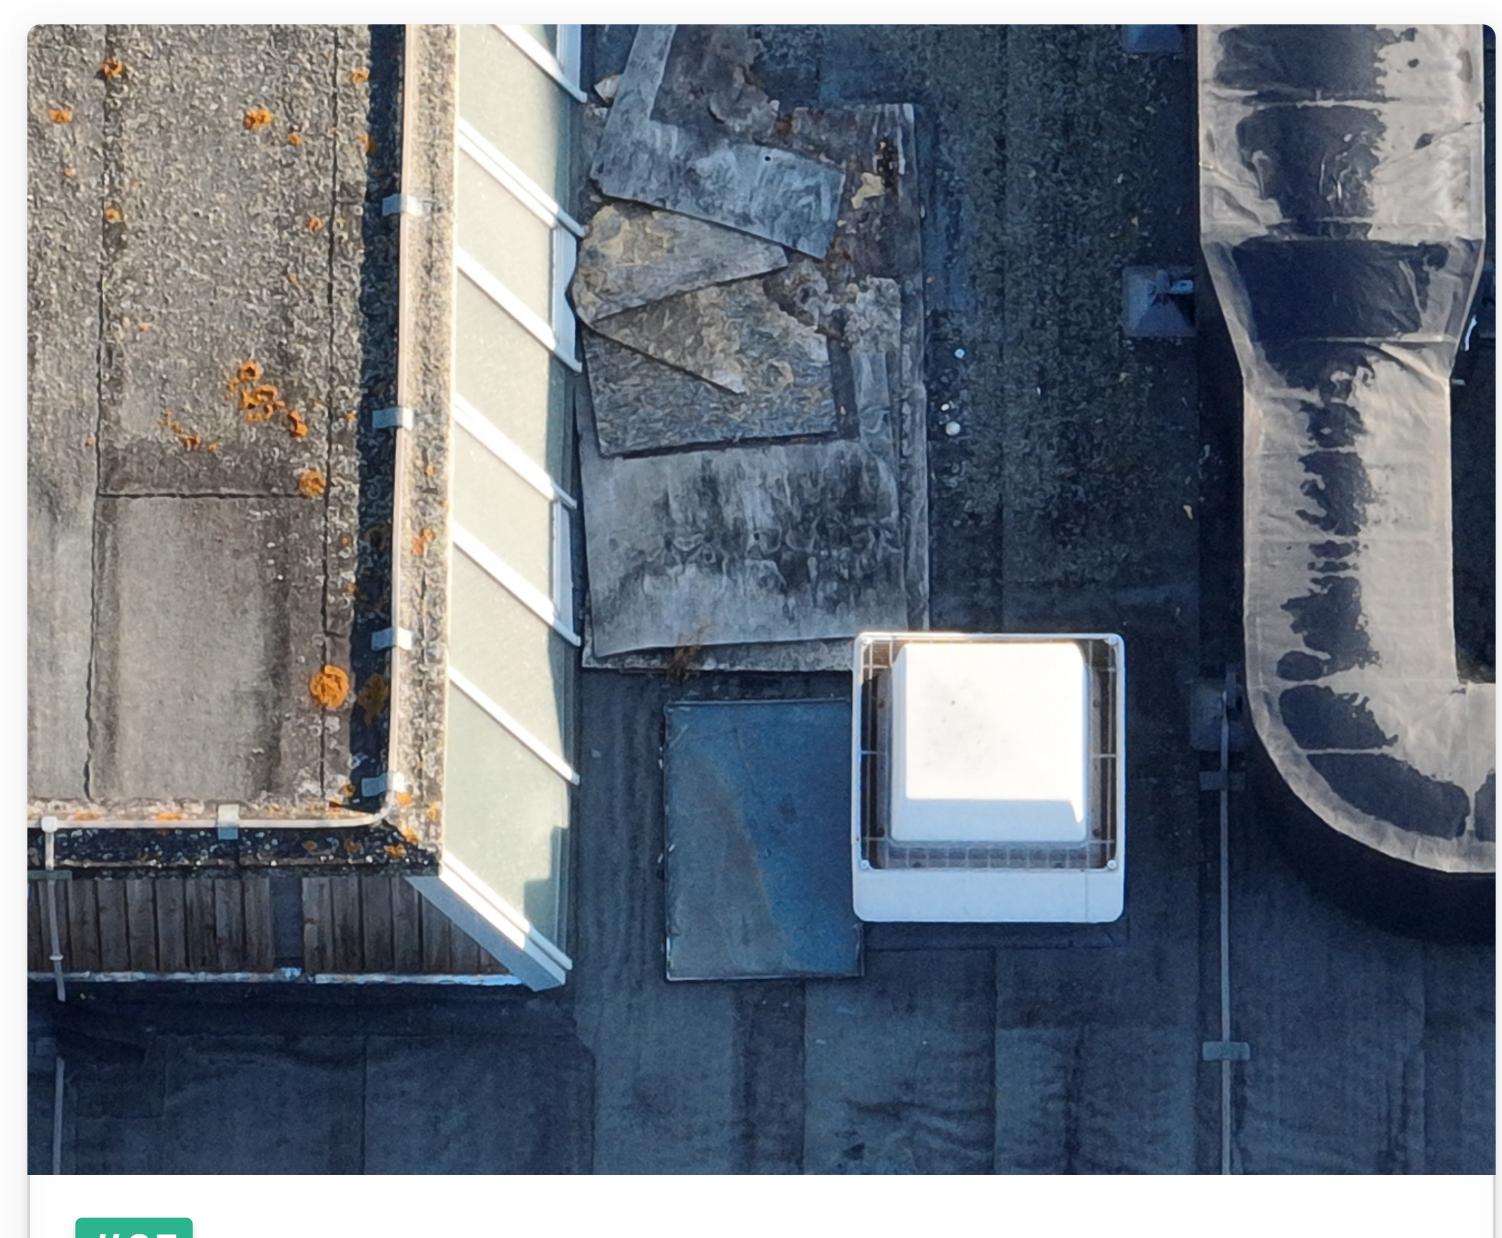
Discarded plywood sheet left on roof

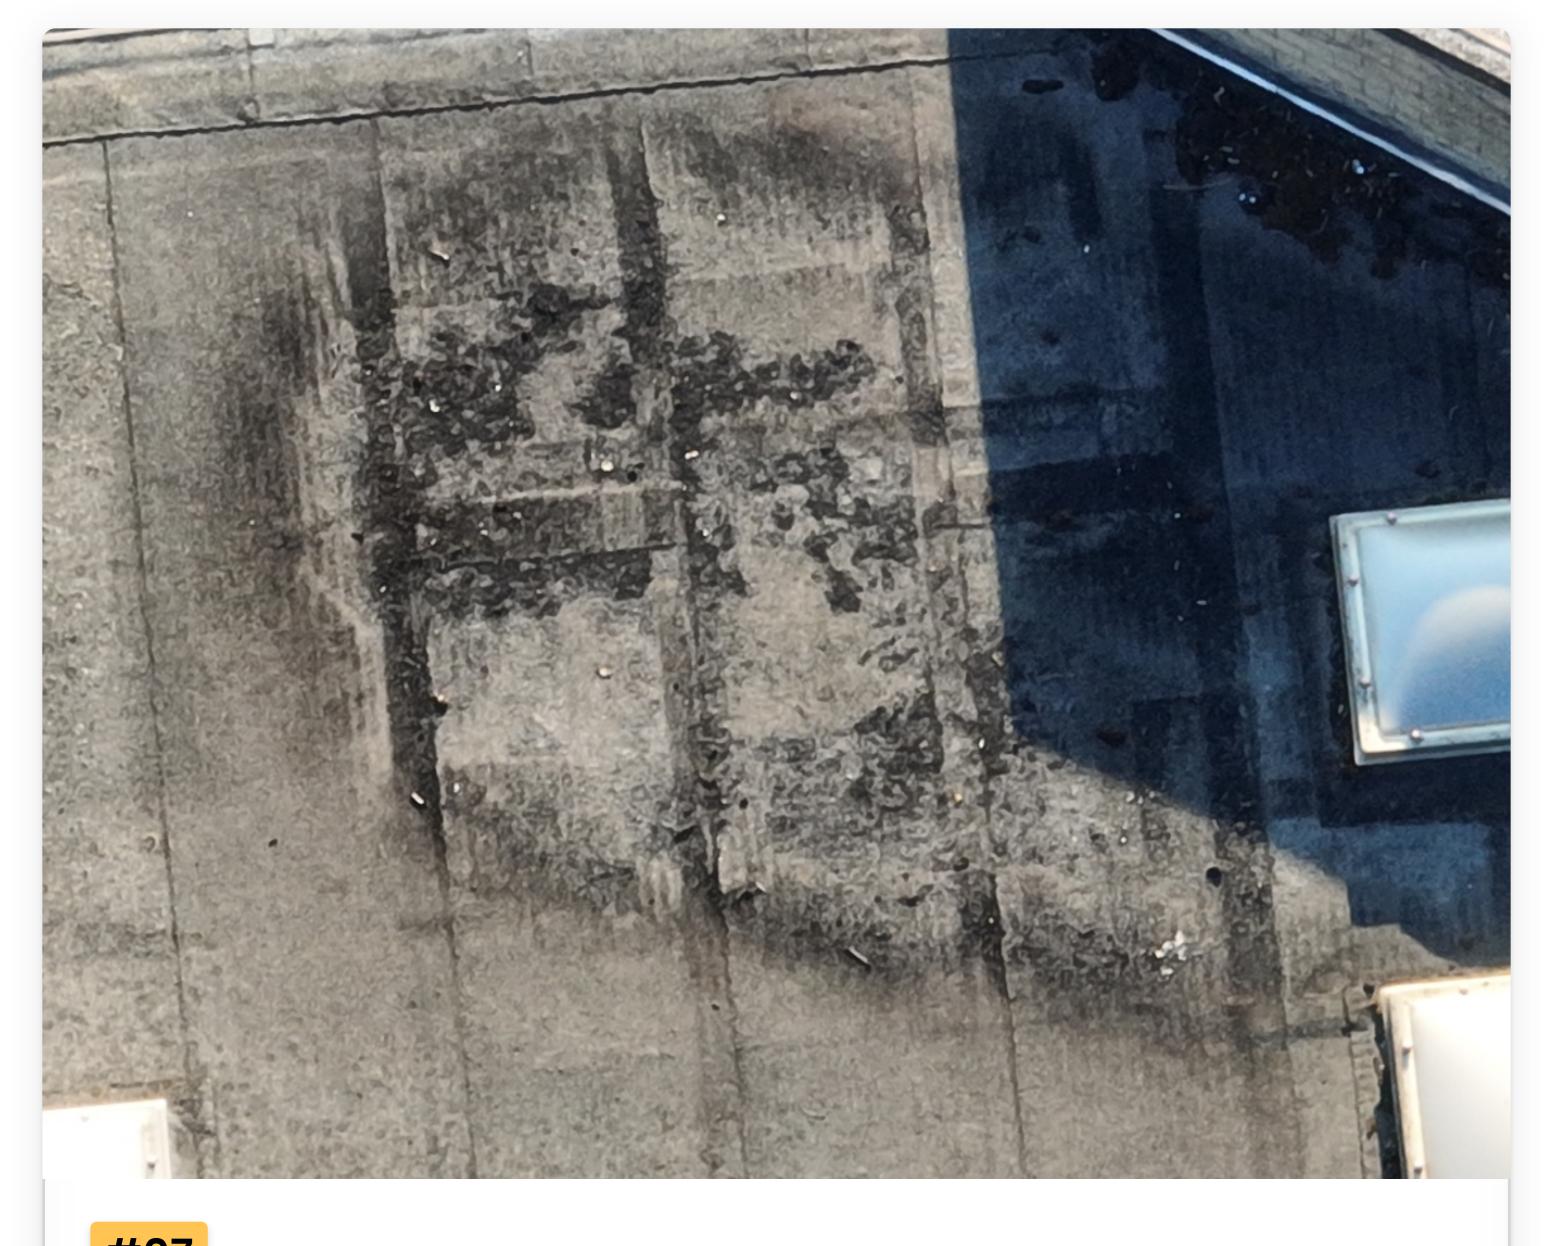
Rain water ponding

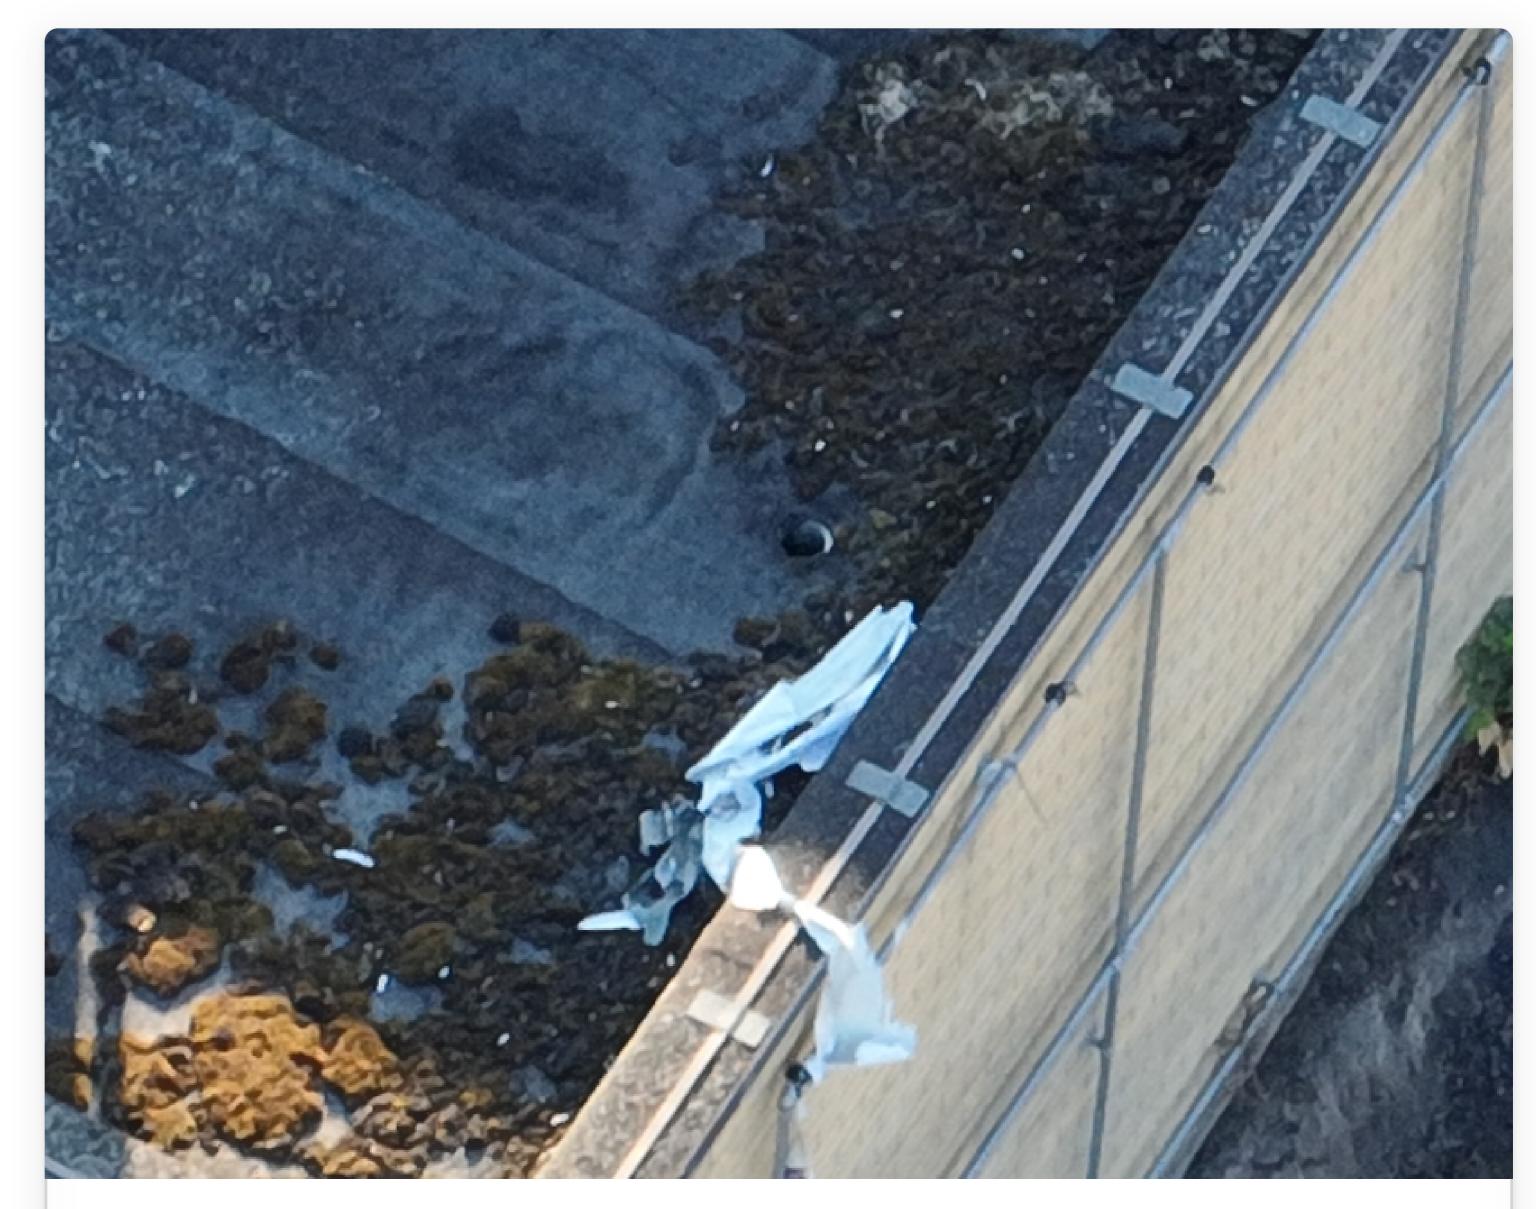
Discarded waste on roof oversailing parapet wall edge

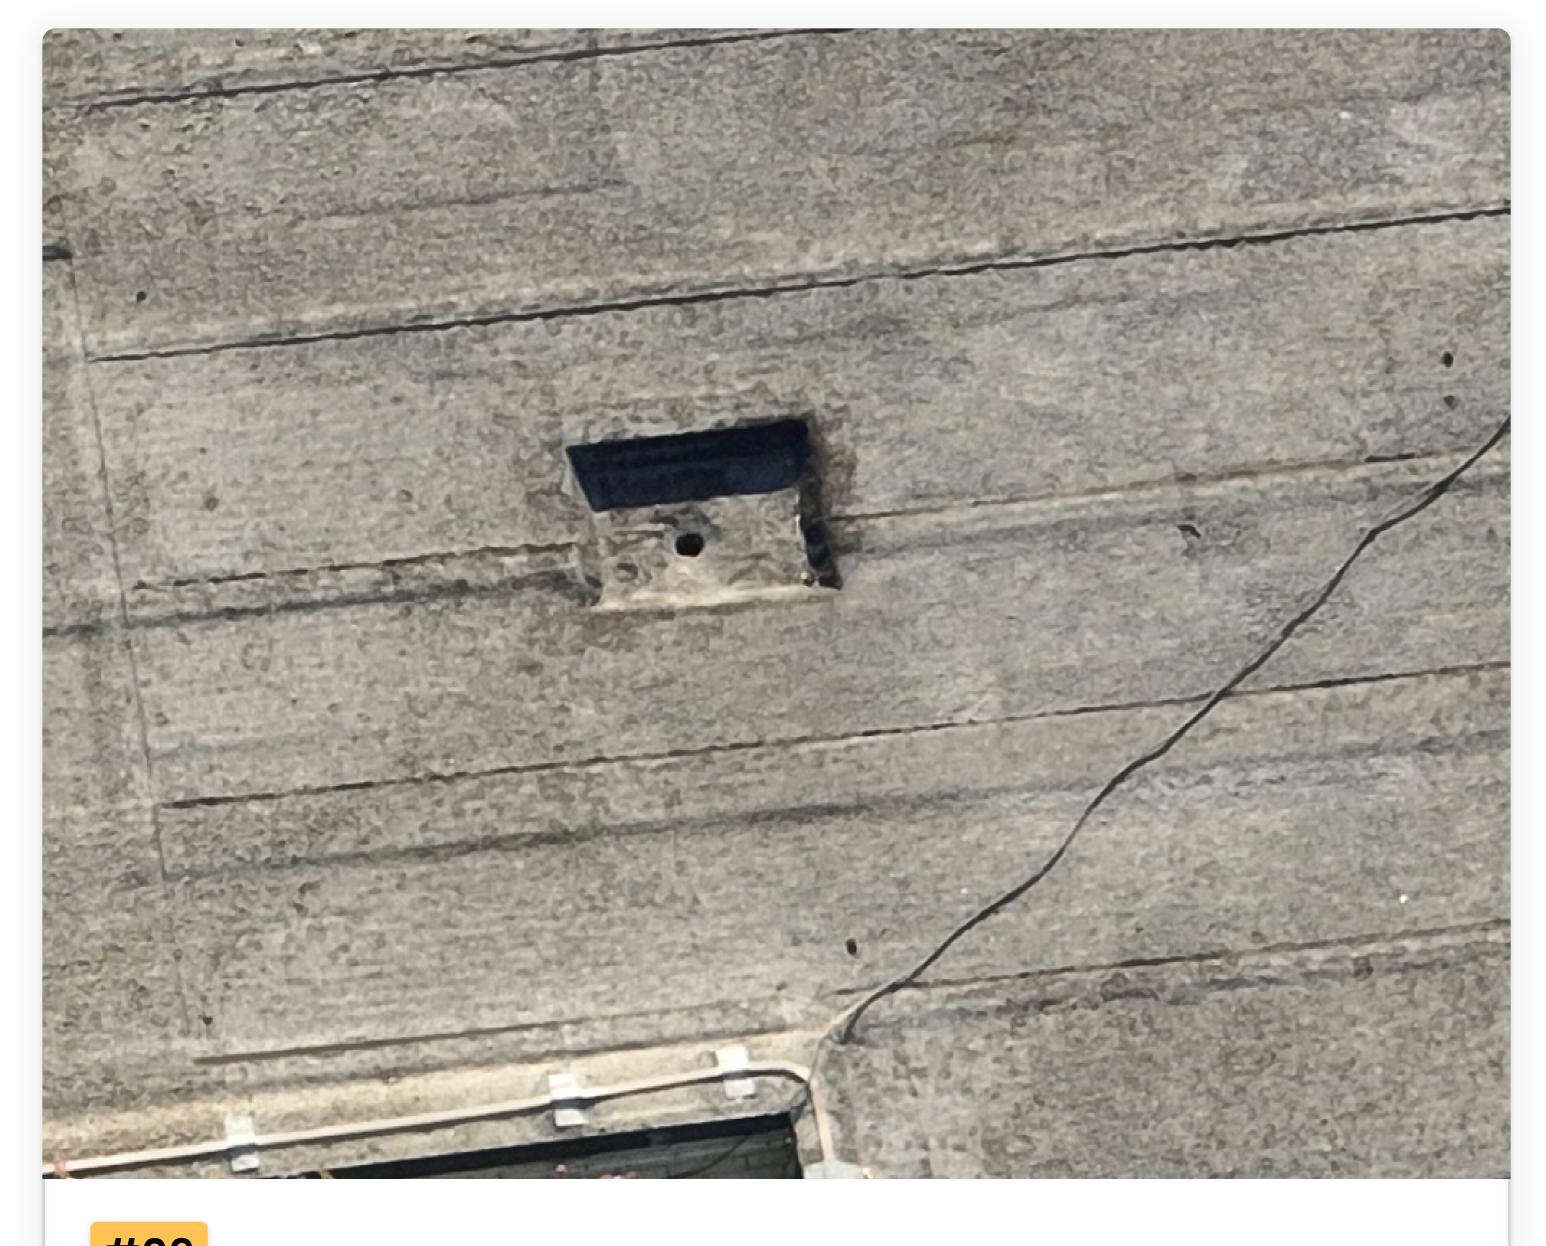
Unprotected and uncovered cable entry route

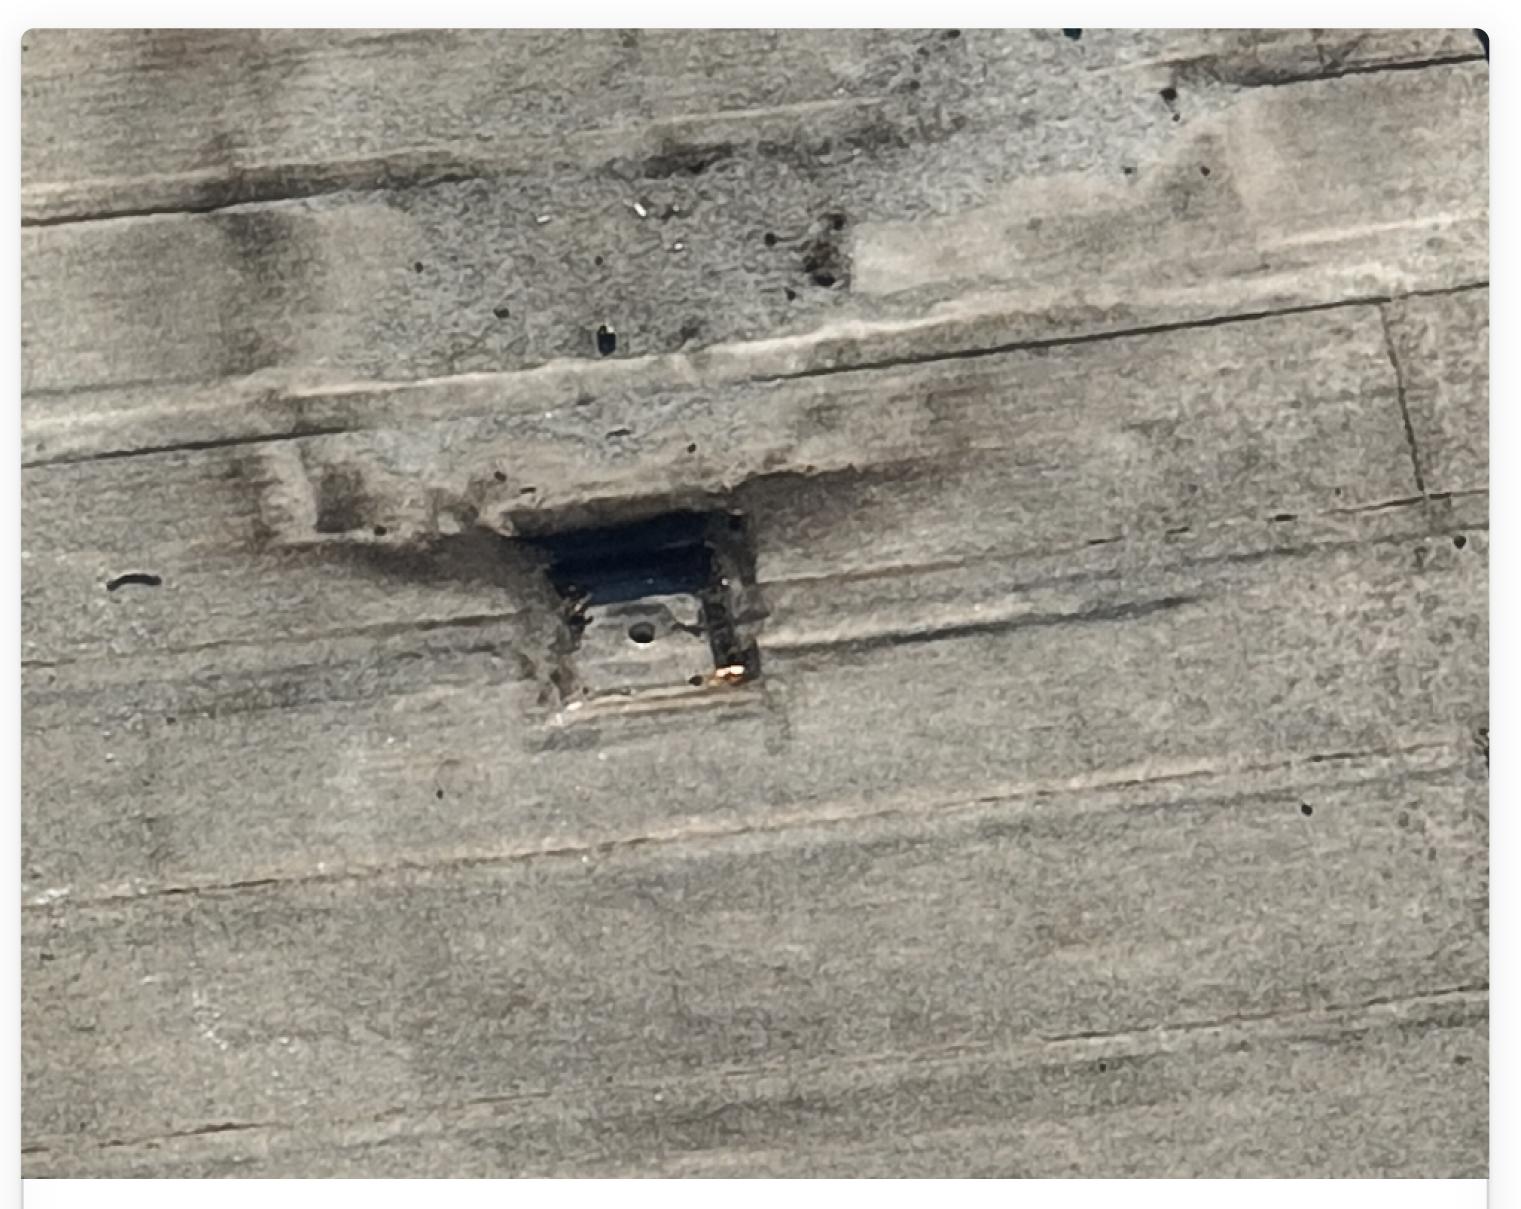
Unprotected and uncovered cable entry route
